Appendix 4c

Blackpool Council Licensing Service				
Representation made by a Responsible Authority in support of an application for the Review of a Premises Licence				
Responsible Authority making representation				
Name of Responsible Authority	Health and Safety			
Name of Officer <i>(please print)</i>	Marcus Maddock			
Signature of Officer

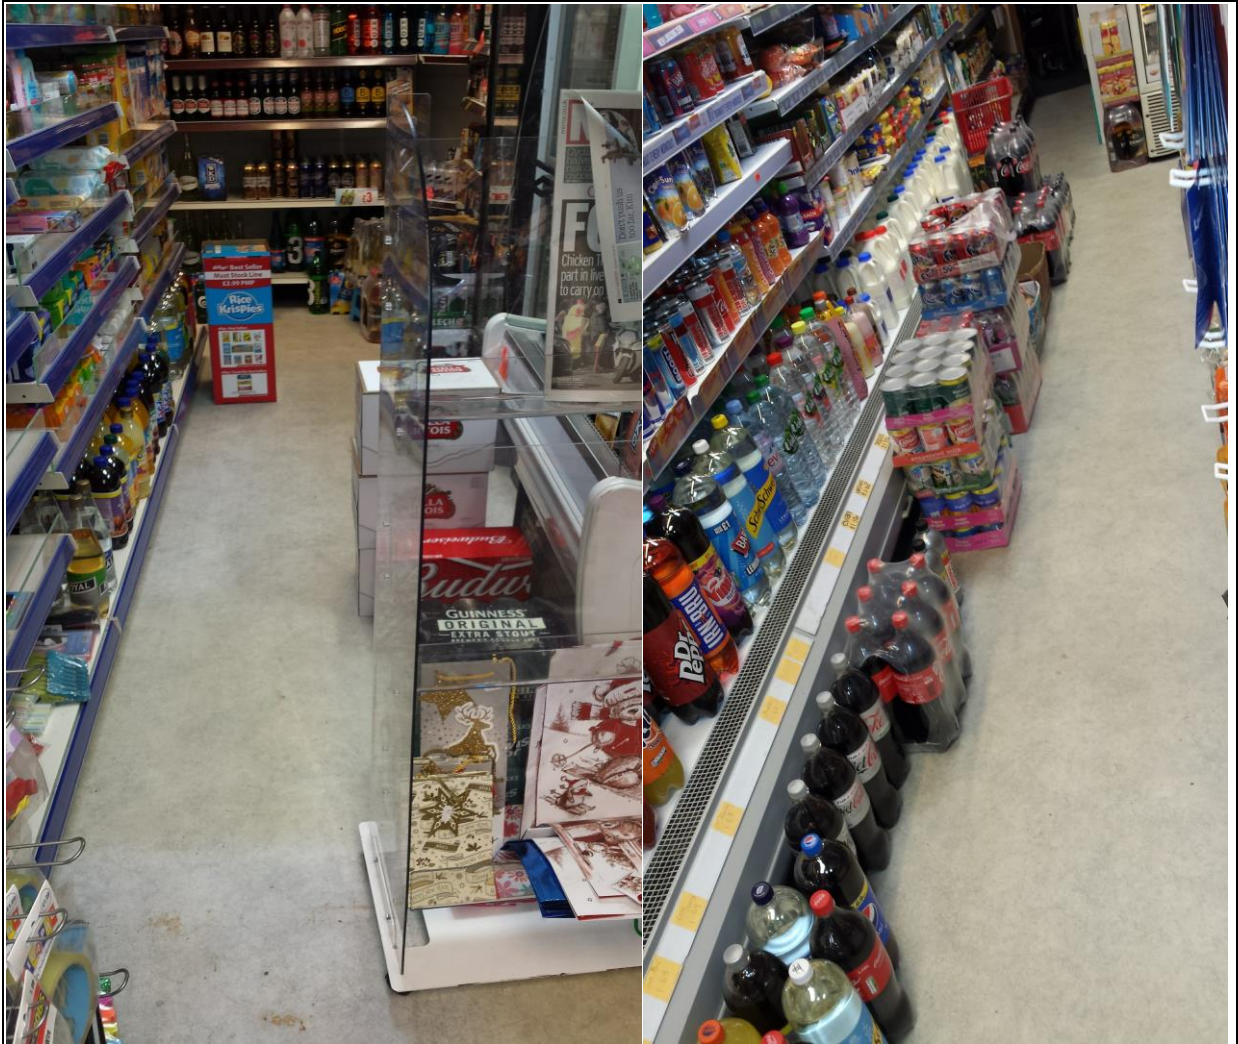
Obstructed traffic routes (front of house), predominantly due to excessive stock levels.

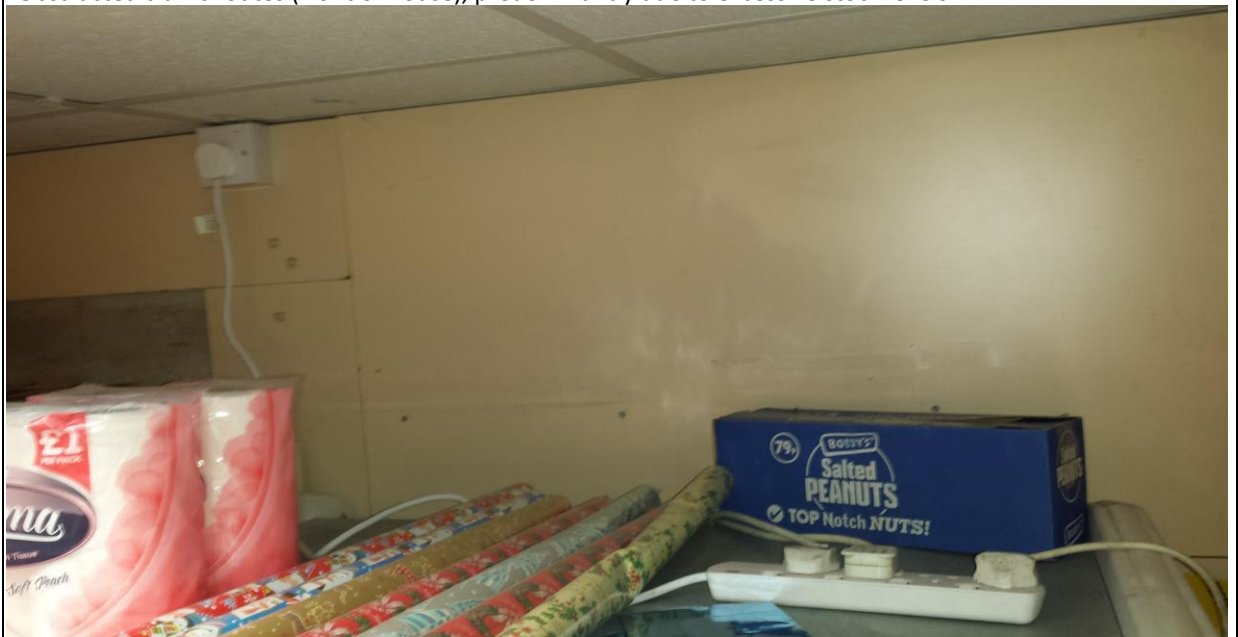
Picture showing 1 socket feeding 3 drinks fridges - under resourced in regards to electrical sockets. Overloaded electricity is a major cause of fire and this extension lead is next items that would easily combust if the socket or wires overheated.

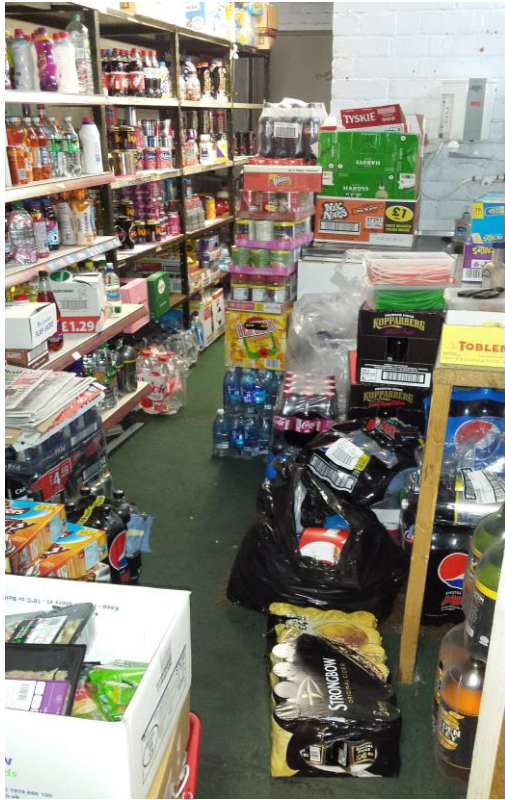
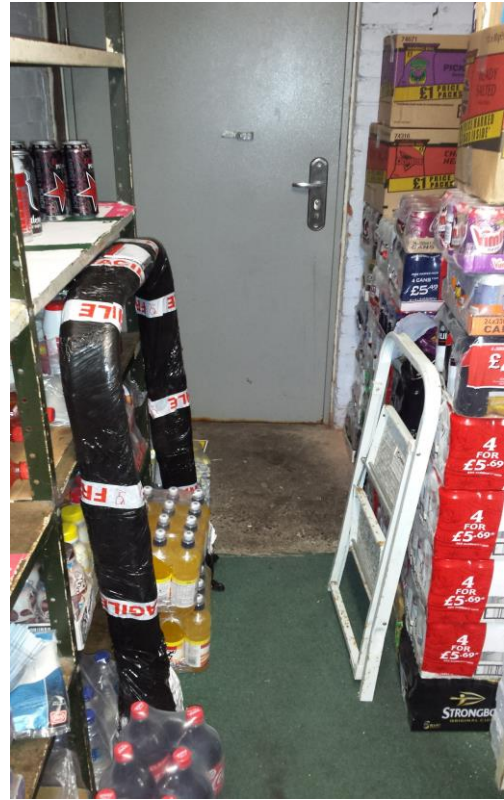
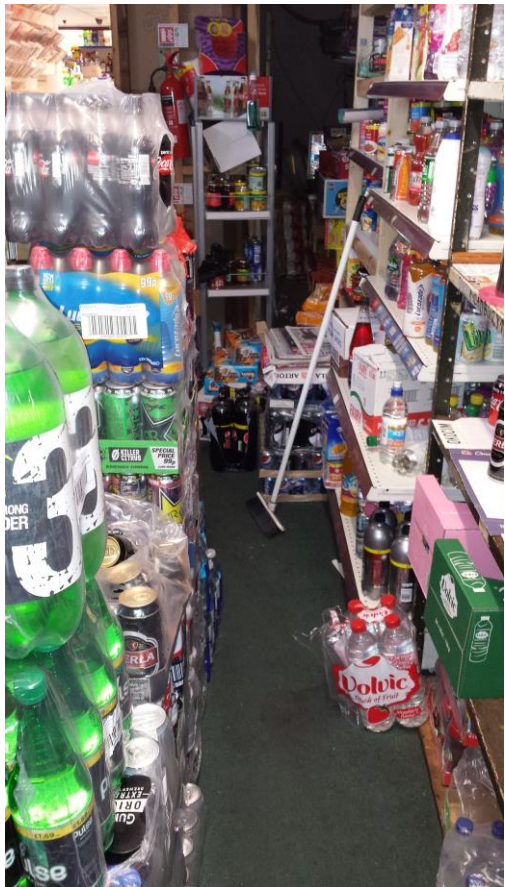
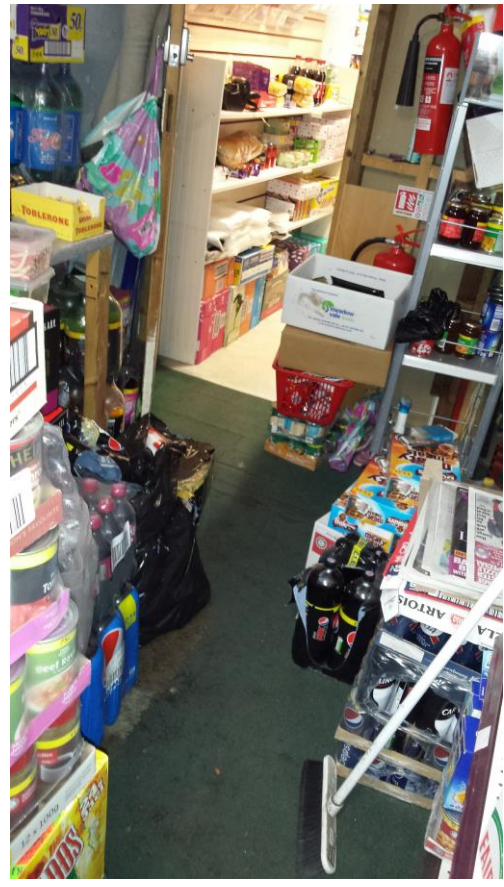
All 4 images showing the access and egress at the back of house. Traffic routes are heavily obstructed with stock. Picture on top right showing the stores emergency exit.

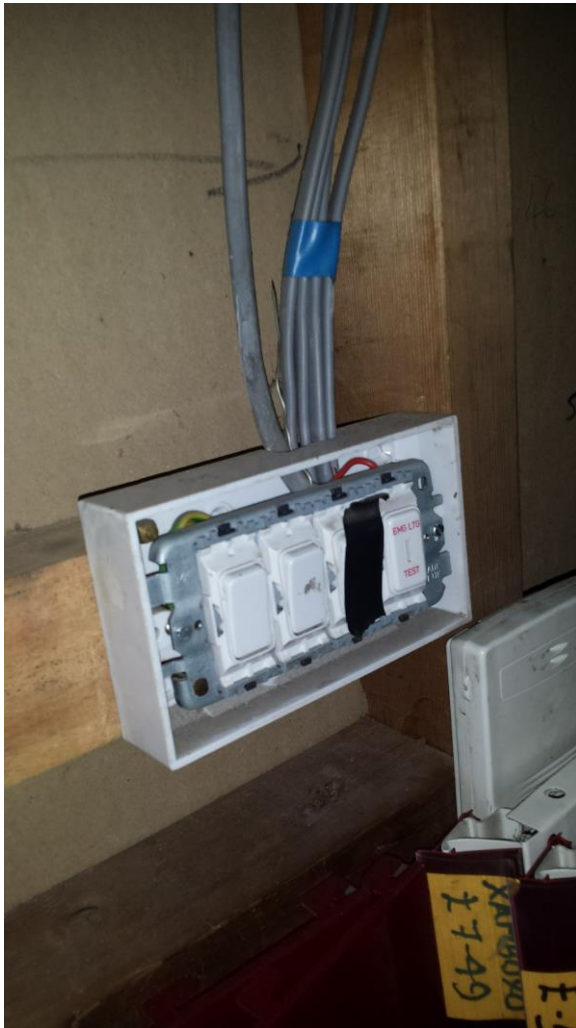
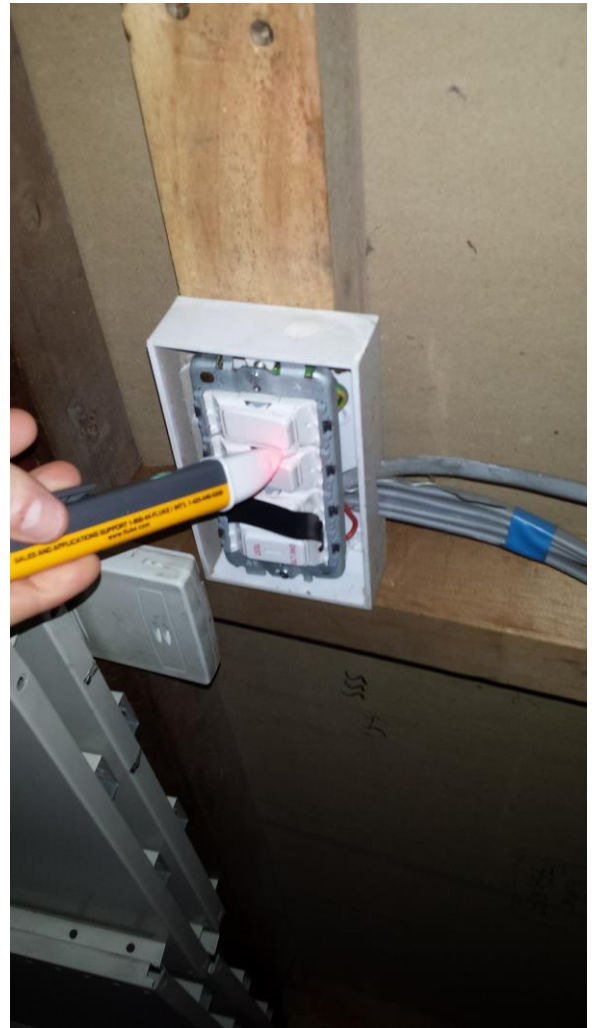
Picture on the left shows a bank of switches with the front casing removed. The picture on the right shows exposed live parts. A degree of protection should be provided so this contravenes Wiring Regulations 2008.

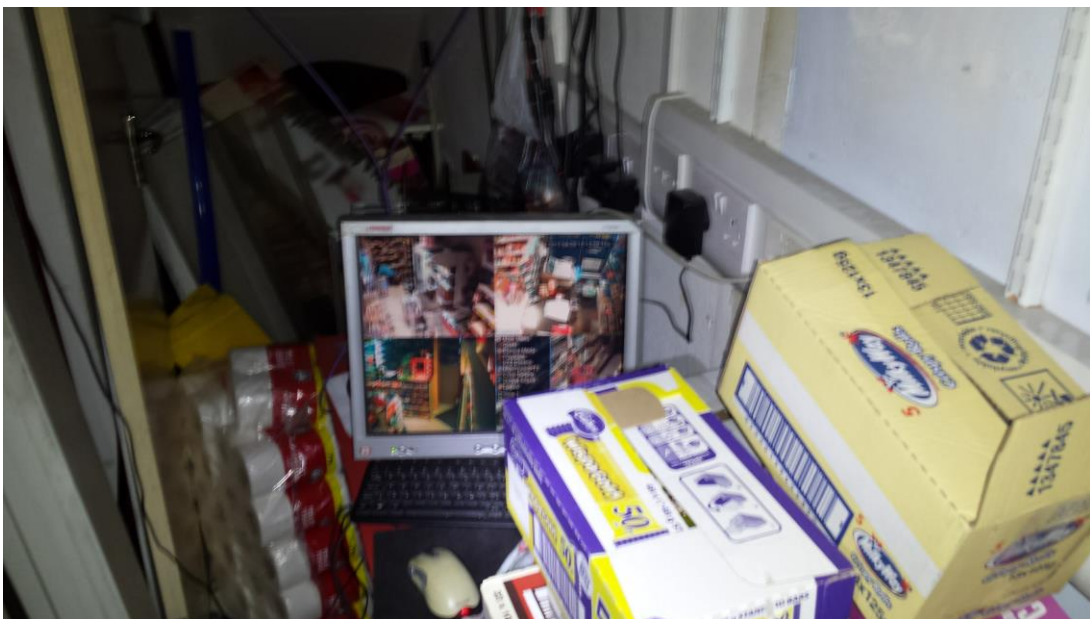
CCTV screen obstructed by excessive stock and empty boxes.

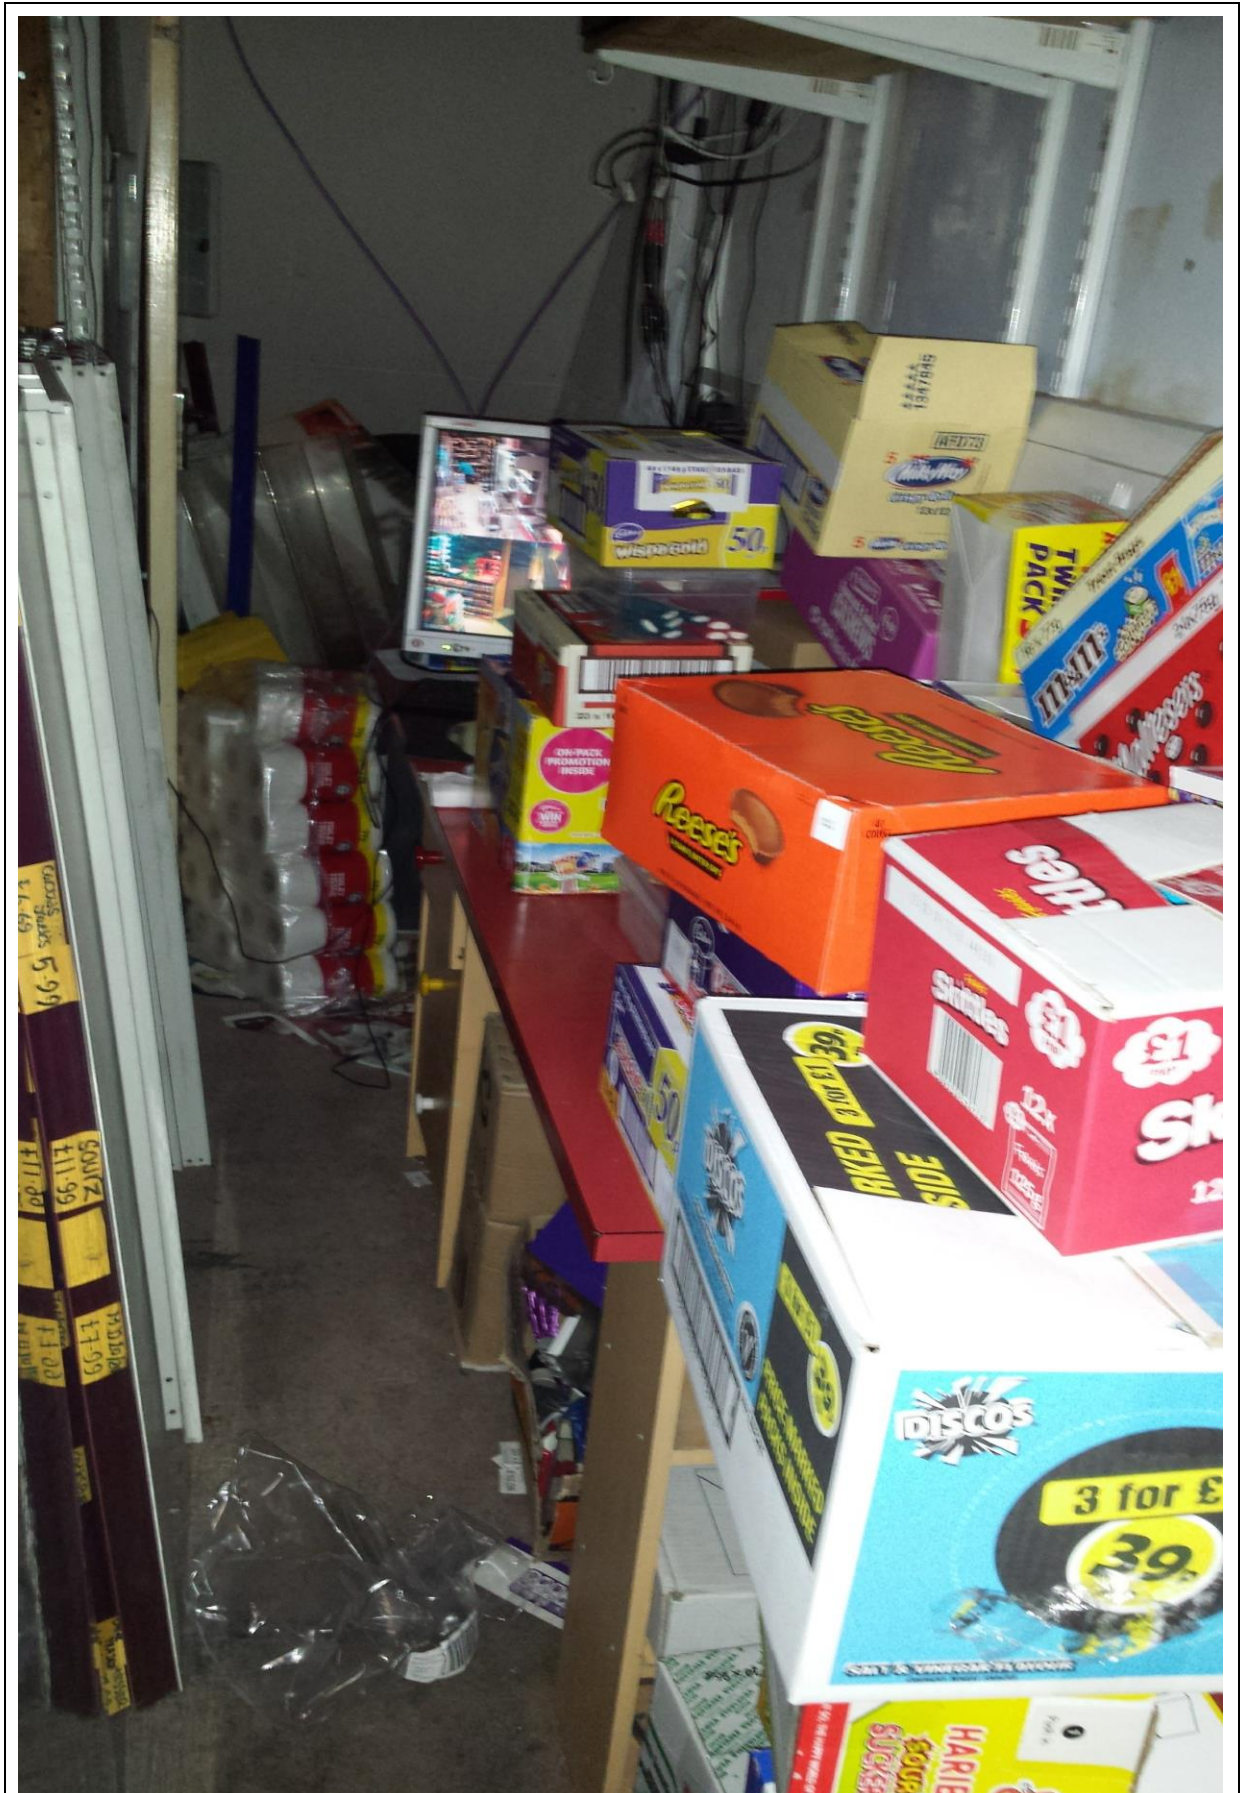
Another picture showing the walkway leading to the CCTV screen.

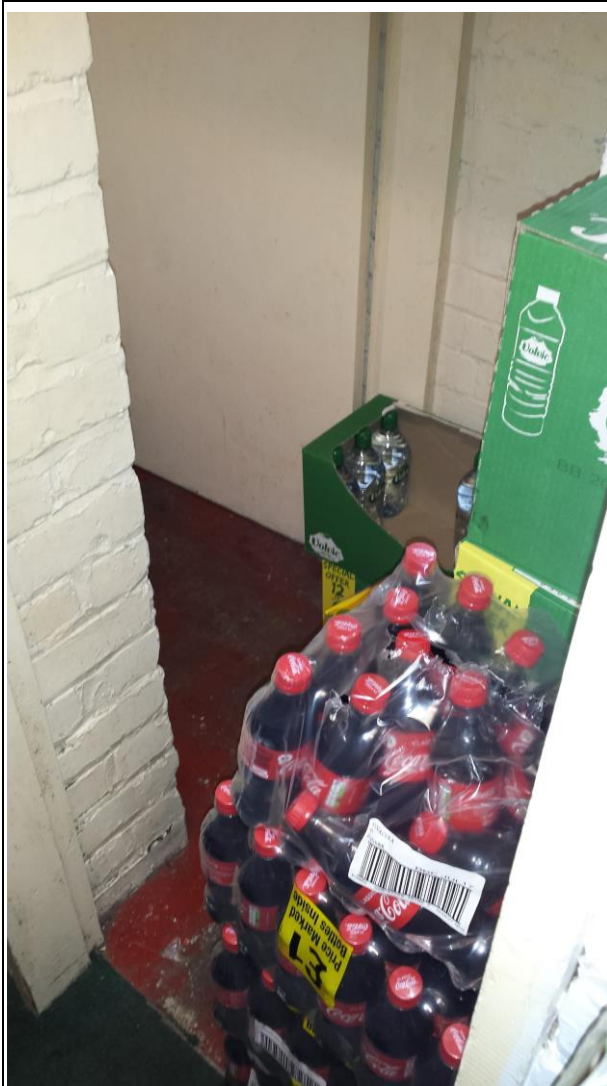
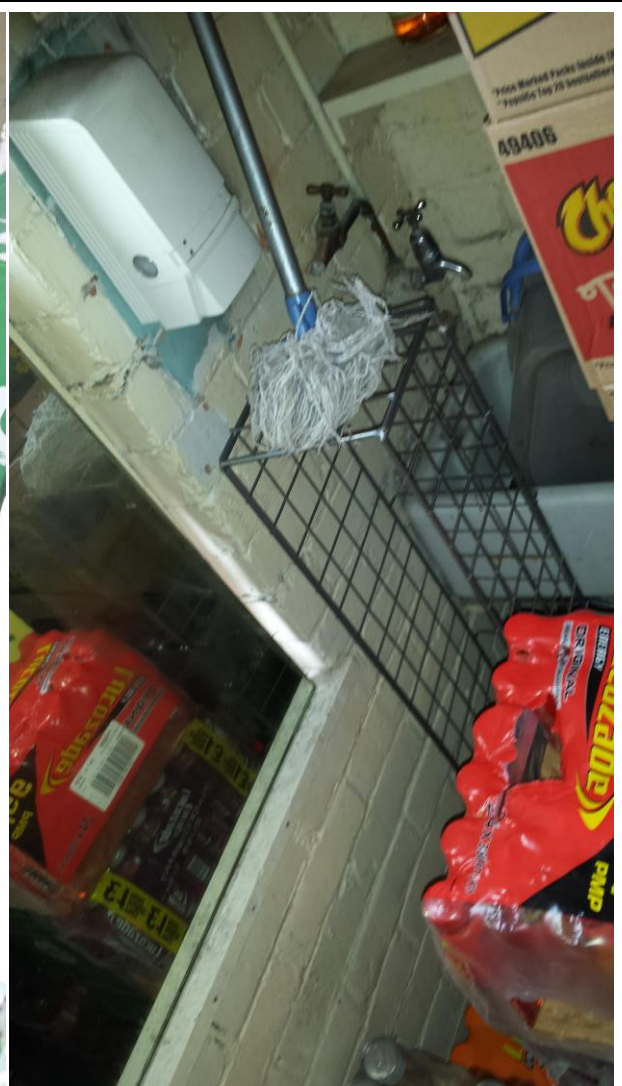
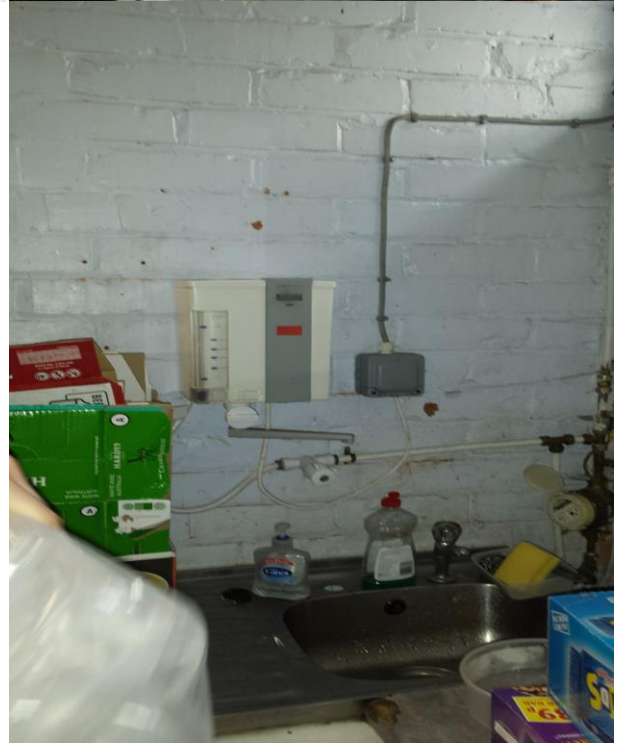
Picture on the left showing the entrance to the staff toilet blocked with stock. Picture on the top right showing more stock blocking access to the hand wash facilities. Bottom right shows additional hand wash facilities in the main store room. Again, obstructed by boxes of shop stock and also bags of rubbish. No soap in the hand soap dispenser and inadequate hot water facilities. Nowhere for staff to dry their hands.
