# Central Library Roof Report

Monday, 07 December 2020

Prepared For Blackpool Council

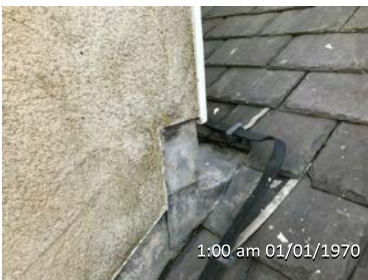
### Area 8

#### Insufficient Slate Cover Over Lead

Steel gutter, flashing and slates need minor work to prevent water ingress.

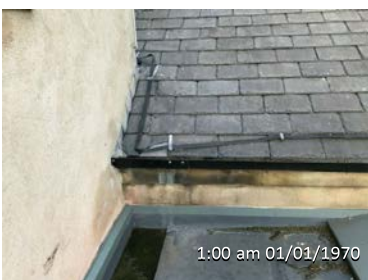
### Area 8

#### Steel Gutter

Steel gutter has insufficient fall and water stains to render indicate that the gutter has been overflowing. Another outlet could be installed to discharge onto the corridor flat roof.
