BUILT HERITAGE AND CONSERVATION TEAM

**PROPOSED NORTH PROMENADE CONSERVATION AREA
CONSERVATION AREA APPRAISAL**

August 2018

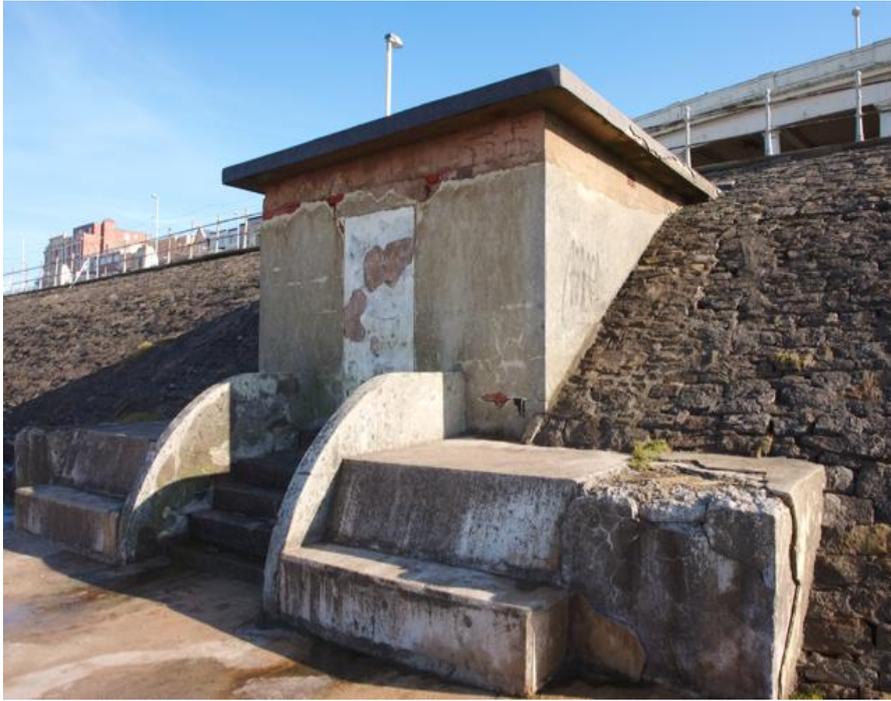
- 5.11 Lower Walk is lined with continuous wooden benching on the inland side, which gives way to unadorned concrete seating further along. There is a small, disused pumping station, which once supplied seawater to a water tower (no longer extant) for distribution to local hotels and the Derby Baths (now demolished). Although outwardly unimpressive, the structure forms part of Blackpool's heritage and early history when the benefits of seawater, and Turkish baths in particular, were so vigorously promoted.

Disused pumping station

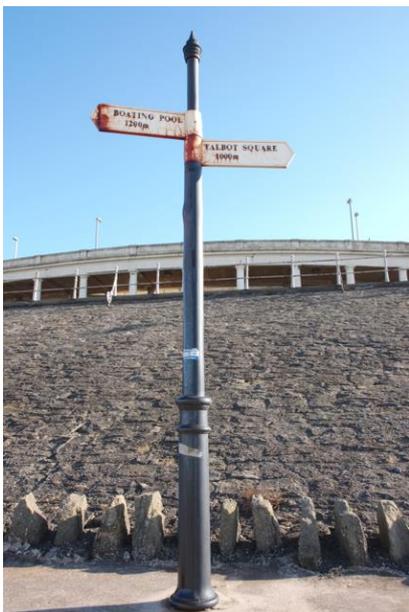
- 5.13 The Cabin Lift forms a prominent focal point, being an impressive structure in its own right. Lower Walk is well provided with street lamps, while there is easy access both to the beach and Middle Walk/Queens Promenade. Life-belts are prominently displayed and rubbish bins are provided. There are two traditional distance markers, though their condition is deteriorating.

Old distance marker, Lower Walk

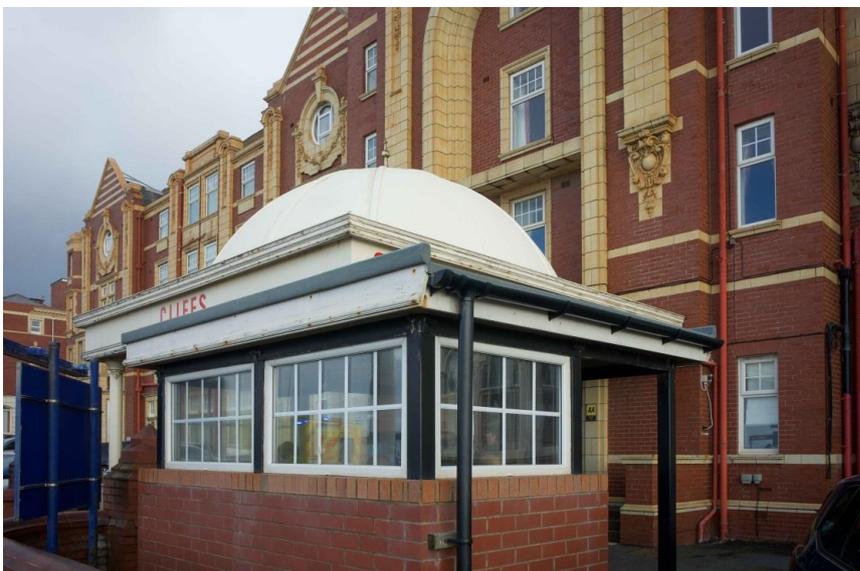
12.1 As discussed, the proposed conservation area benefits from a high level of completeness. Conservation area designation seeks to retain existing character, and encourage enhancement where modern interventions have resulted in a loss of historic character, for example by uPVC replacement windows, the erection of sun lounges and smoking shelters.

Smoking shelter, Cliffs Hotel

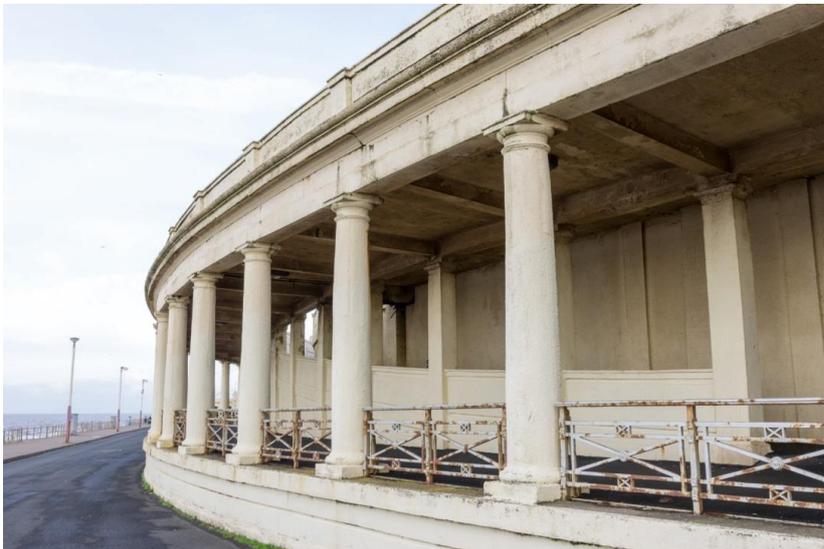
- 12.2 The conservation area survey revealed that poor maintenance is an issue which affects the visual amenity of the area. The colonnades and twin pillars to the Middle Walk are in need of cleaning and painting, while the panelled sides of the interior paths to the Promenade are in poorer condition with paint flaking off ten side panels. The physical fabric of the colonnades shows some minor signs of deterioration. The capitals of twelve of the columns have been repaired or are in need of repair. There are signs of the concrete itself corroding, though to a minor degree only. The colonnade on the Lower Walk is also in need of repair and redecoration.

Railings in need of repainting

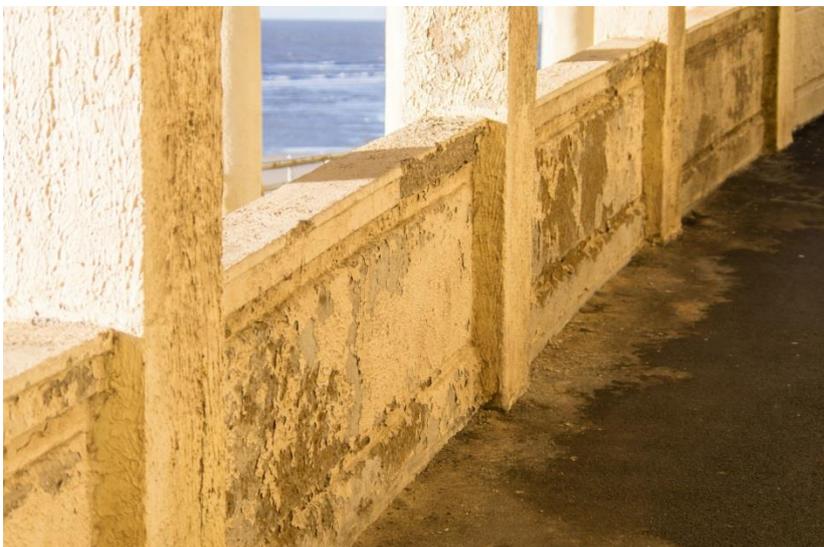
Interior paintwork to enclosed walkway

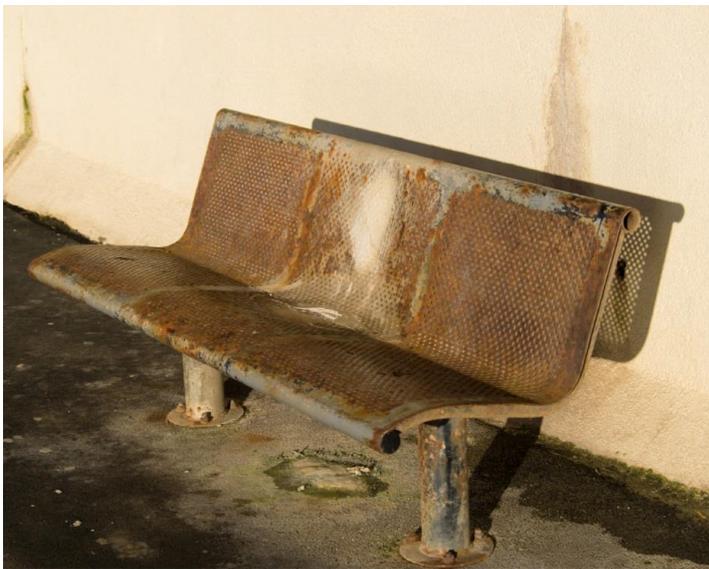
- 12.3 The metal benches inside the covered walkways linking the colonnades are in very poor condition and are badly rusted, and a rusty container unit appears to be permanently parked by the side of the southernmost colonnade.

Rusting bench

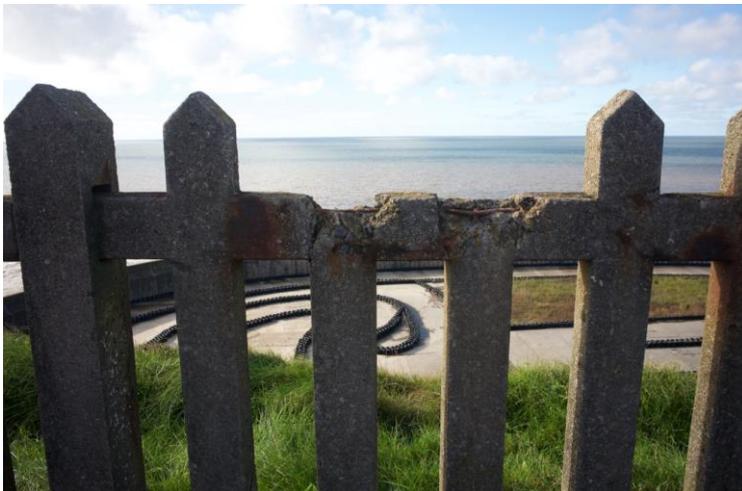
- 12.4 Some of the boundary treatments are also in need of repair, for example the concrete fencing and metal railings.

Corroding concrete fencing

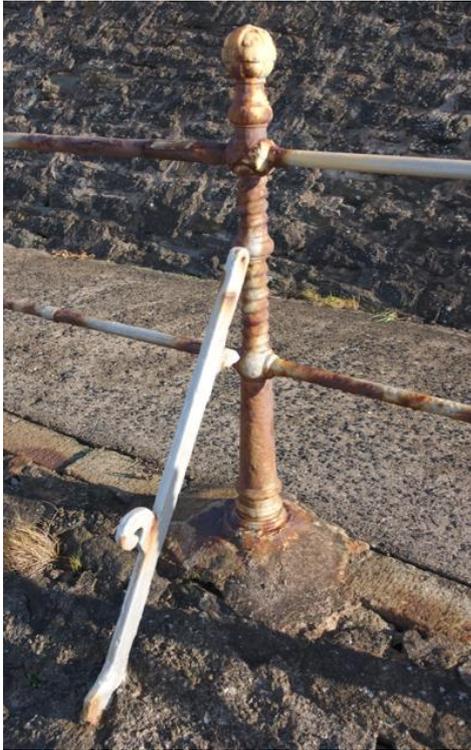
Corroding balustrade

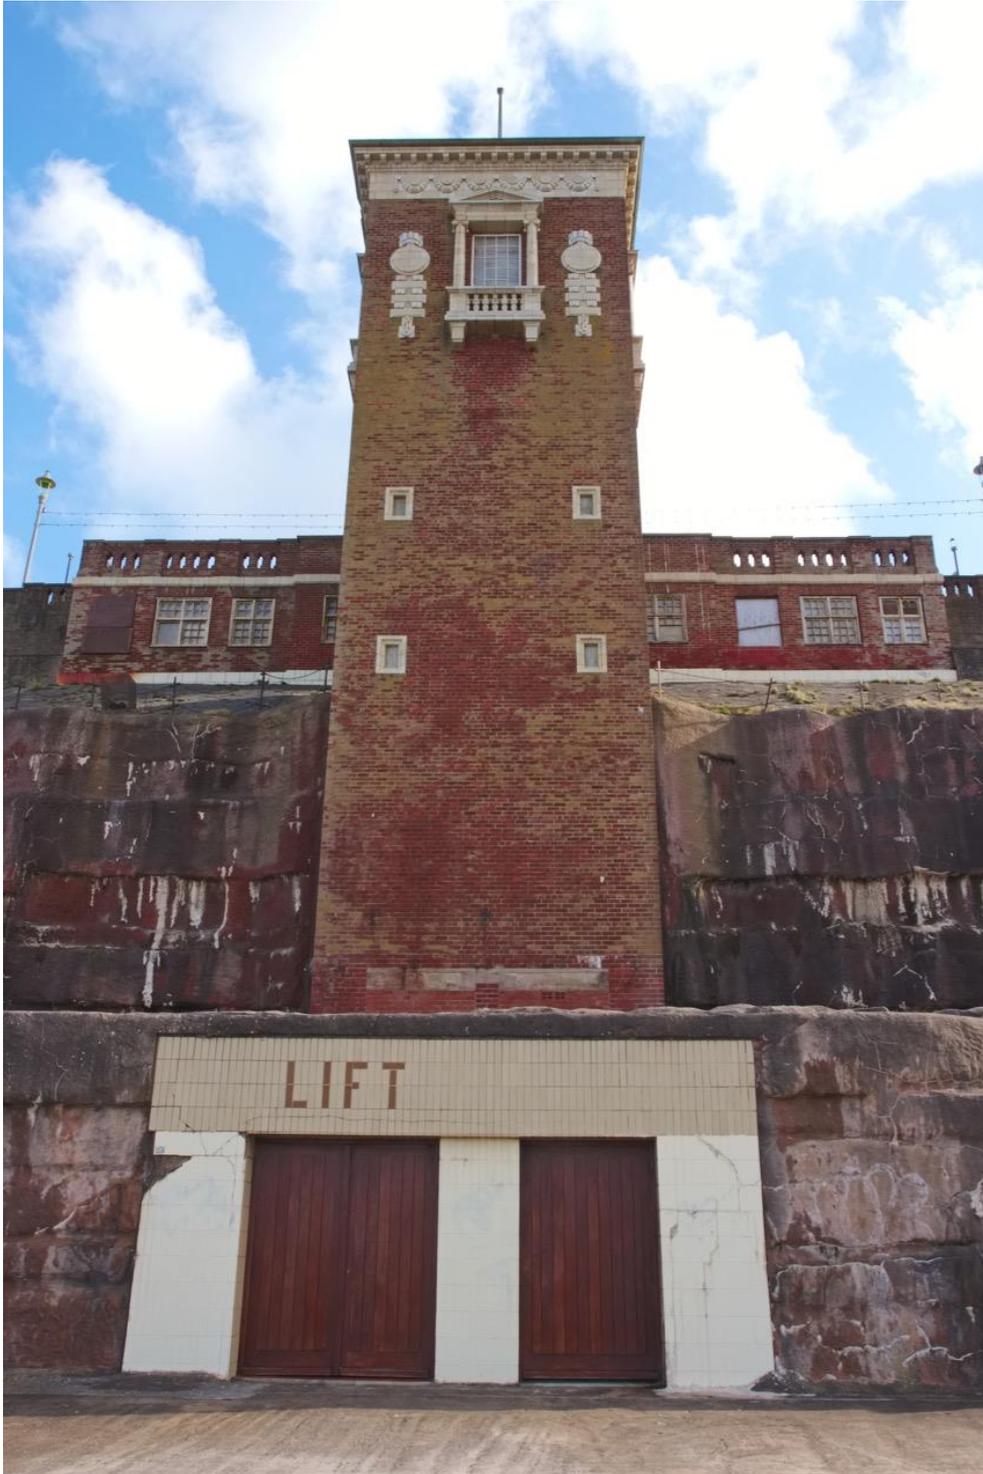
- 12.5 The banked pathways leading up to the colonnades are well maintained with sound tarmac surfaces and the provision in some cases of metal handrails/railings. The concrete flags covering the raised banks have worked loose in several areas; some have come away completely and require attention.
- 12.6 The Grade 2 cabin lift is in a state of disrepair with cracking to the tower, broken windows and rusting doors. The copper roof was replaced a few years ago to remedy water ingress, and repairs were carried out to the faience, but the building continues to deteriorate. A new use, and perhaps a new owner, needs to be found in order to ensure that the building is saved for future generations.

Entrance to non-functioning lift from Lower Walk

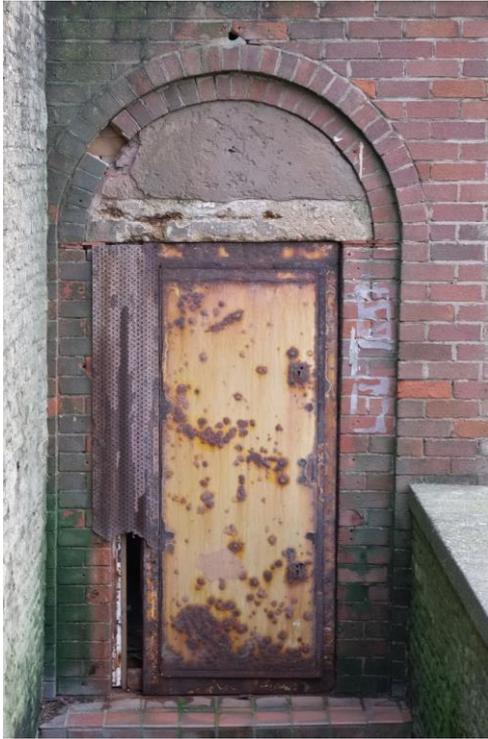
Badly rusting doors to disused toilets under Promenade lift entrance

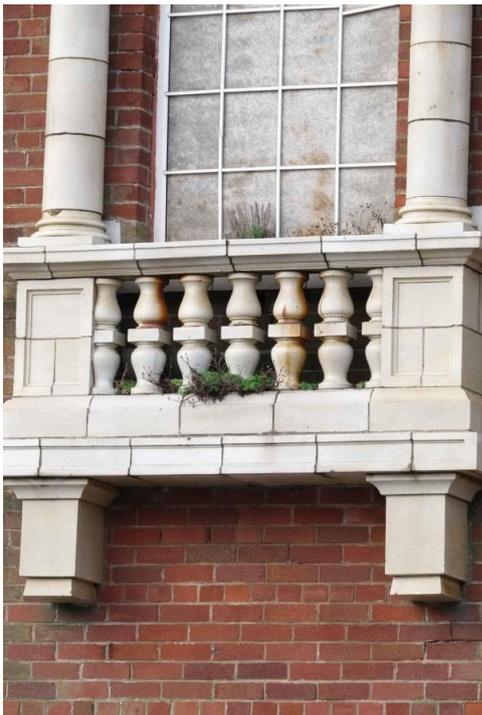
Plant growth on decorative faience
