BUILT HERITAGE AND CONSERVATION TEAM

NORTH PROMENADE CONSERVATION AREA CONSERVATION AREA APPRAISAL

December 2018

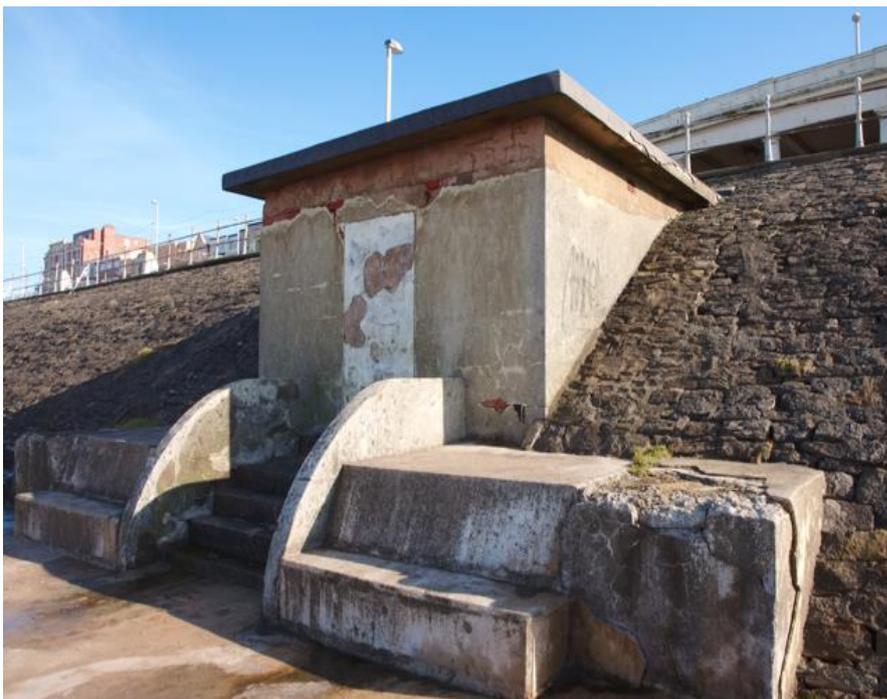
- 7.9 Lower Walk is lined with continuous wooden benching on the inland side, which gives way to unadorned concrete seating further along. There is a small, disused pumping station, which once supplied seawater to a water tower (no longer extant) for distribution to local hotels and the Derby Baths (now demolished). Although outwardly unimpressive, the structure forms part of Blackpool's heritage and early history when the benefits of seawater, and Turkish baths in particular, were so vigorously promoted.

Disused pumping station

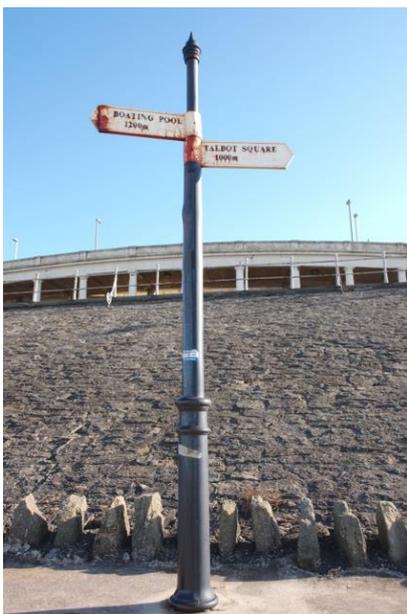
- 7.11 The Cabin Lift forms a prominent focal point, being an impressive structure in its own right. Lower Walk is well provided with street lamps, while there is easy access both to the beach and Middle Walk/Queens Promenade. Life-belts are prominently displayed and rubbish bins are provided. There are two traditional distance markers, though their condition is deteriorating.

Old distance marker, Lower Walk

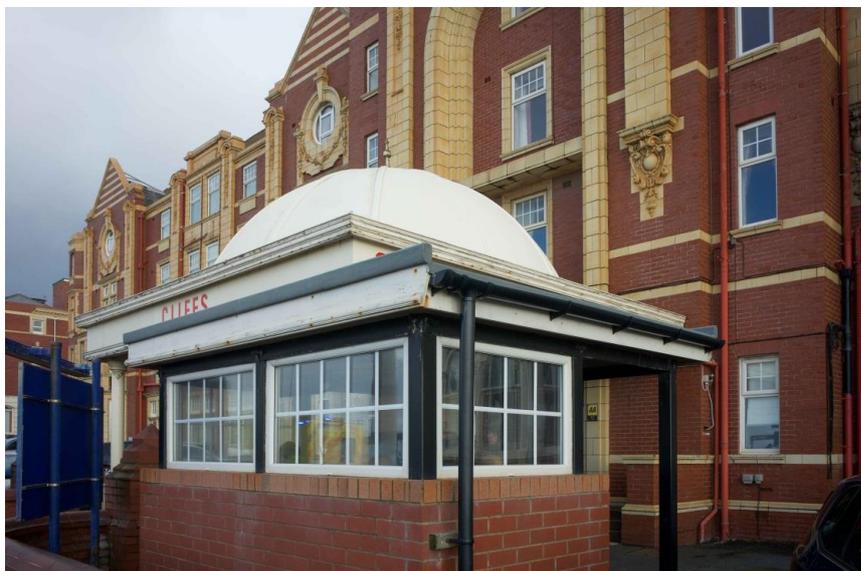
13.1 The conservation area benefits from a high level of completeness. Conservation area designation seeks to retain existing character, and encourage enhancement where modern interventions have resulted in a loss of historic character, for example by uPVC replacement windows, the erection of sun lounges and smoking shelters.

Smoking shelter, Cliffs Hotel

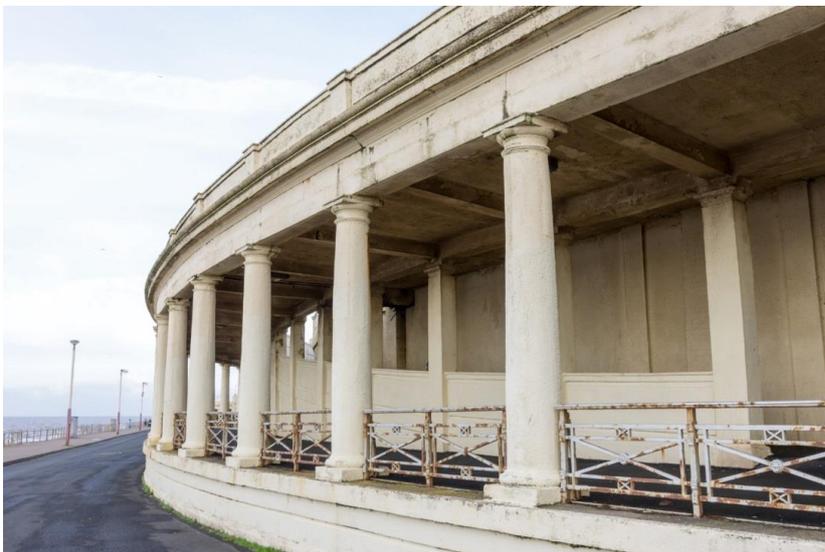
- 13.2 The conservation area survey revealed that poor maintenance is an issue which affects the visual amenity of the area. The colonnades and twin pillars to the Middle Walk are in need of cleaning and painting, while the panelled sides of the interior paths to the Promenade are in poorer condition with paint flaking off ten side panels. The physical fabric of the colonnades shows some minor signs of deterioration. The capitals of twelve of the columns have been repaired or are in need of repair. There are signs of the concrete itself corroding, though to a minor degree only. The colonnade on the Lower Walk is also in need of repair and redecoration.

Railings in need of repainting

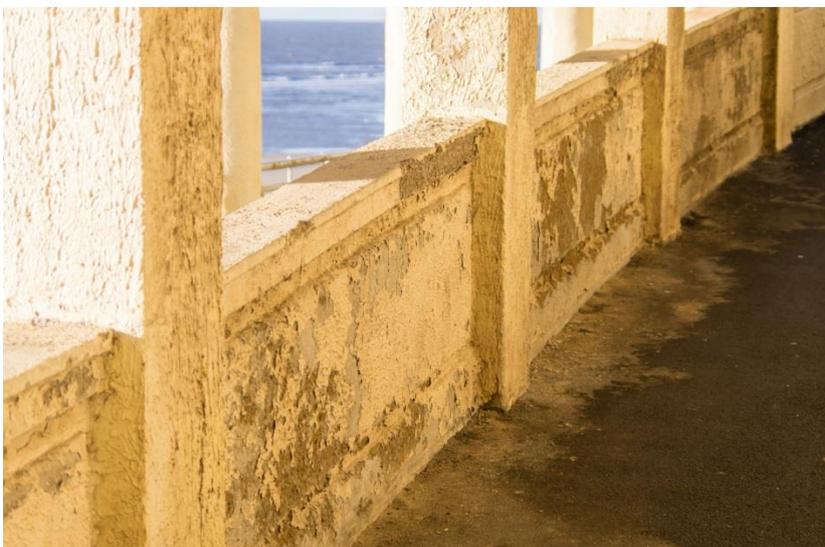
Interior paintwork to enclosed walkway

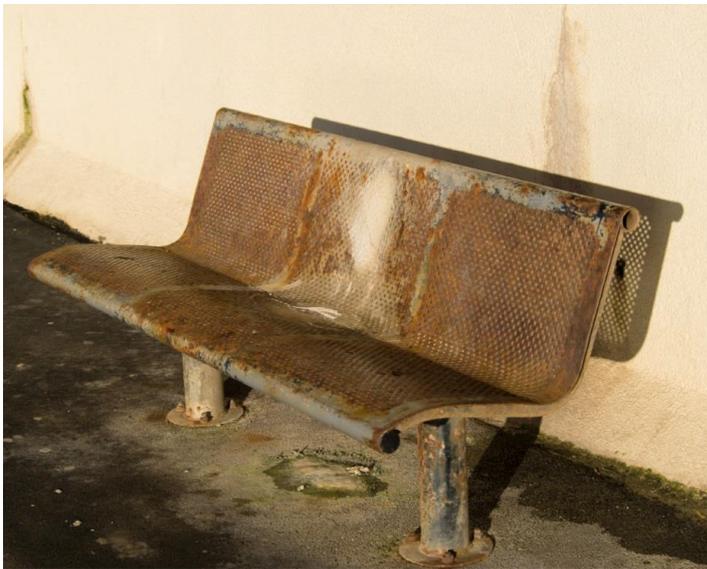
- 13.3 The metal benches inside the covered walkways linking the colonnades are badly rusted and in very poor condition, and should be replaced with benches of an appropriate design whenever possible. A rusty container unit parked by the side of the southernmost colonnade also detracts from the visual appearance of the conservation area.

Rusting bench

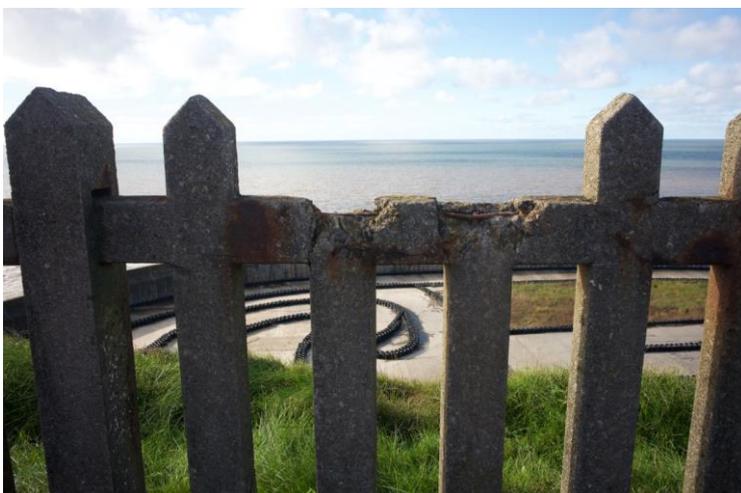
- 13.4 Some of the boundary treatments are also in need of repair, for example the concrete fencing and metal railings.

Corroding concrete fencing

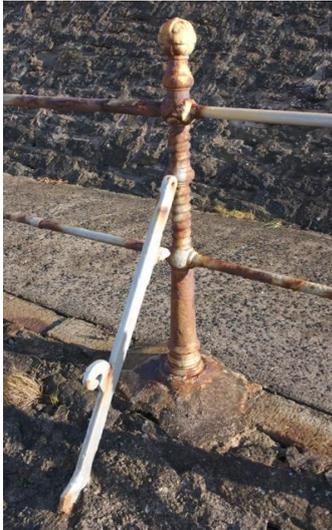
Corroding balustrade

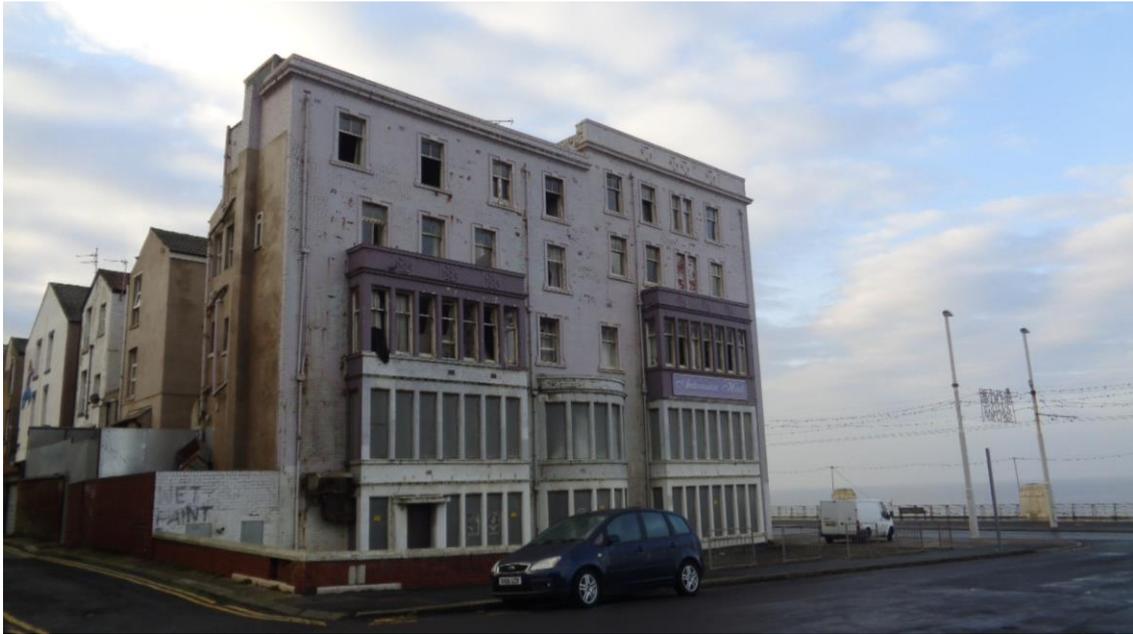
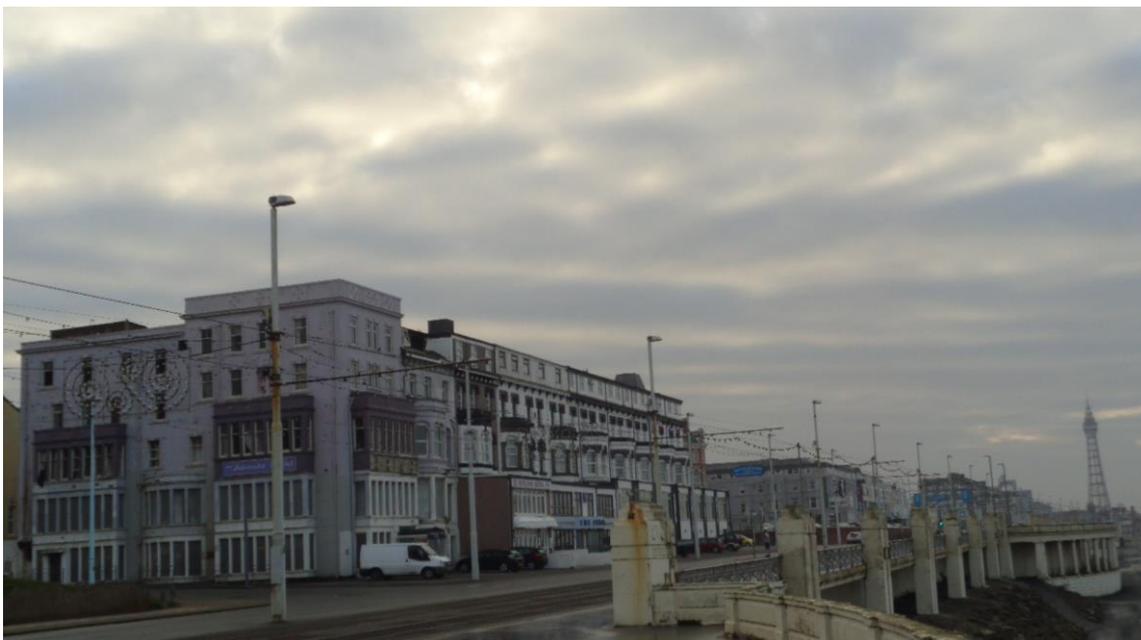
- 13.9 Modern windows and sun lounges aside, the condition of most of the hotels is good apart from the Ambassador Hotel adjacent to the former Hilton Hotel. The hotel is in very poor repair and detracts from the amenity value of the conservation area. However, it retains many original features and could be restored so that it makes a strong positive contribution to the character and appearance of the conservation area.

Ambassador Hotel viewed from Derby Road

Ambassador Hotel viewed from the headland opposite the former Hilton Hotel

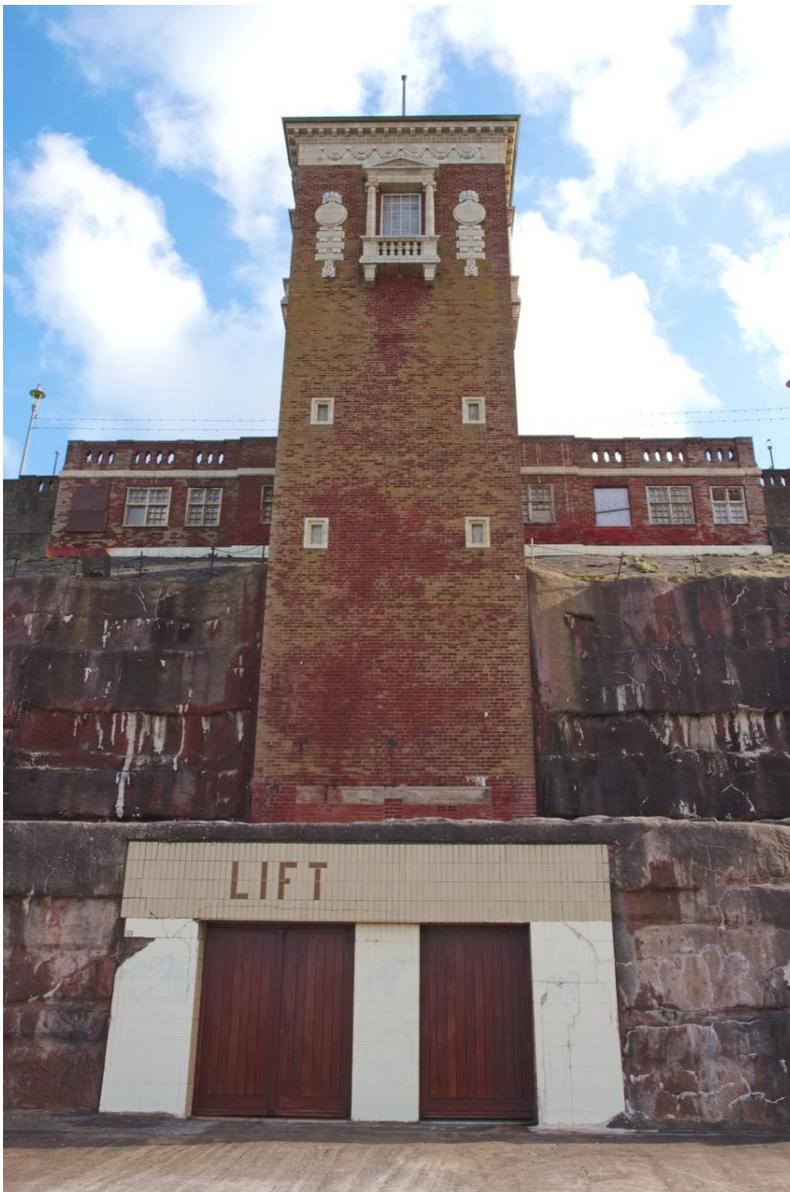
- 13.6 The Grade 2 cabin lift is in a state of disrepair with cracking to the tower, broken windows and rusting doors. The copper roof was replaced a few years ago to remedy water ingress, and repairs were carried out to the faience, but the building continues to deteriorate. A new use, and perhaps a new owner, needs to be found in order to ensure that the building is saved for future generations.

Entrance to non-functioning lift from Lower Walk

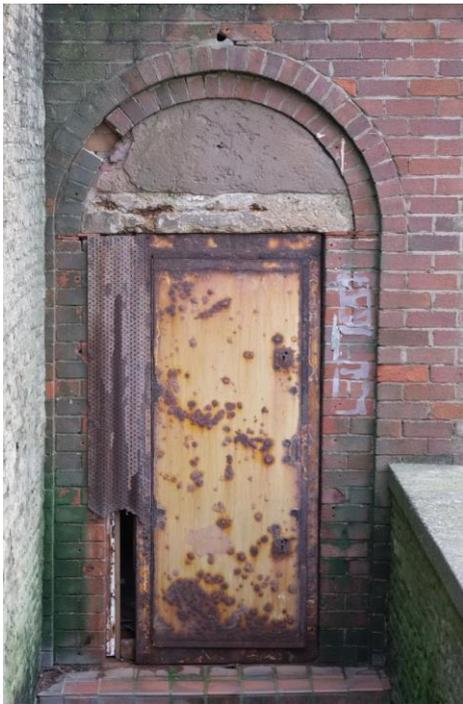
Badly rusting doors to disused toilets under Promenade lift entrance

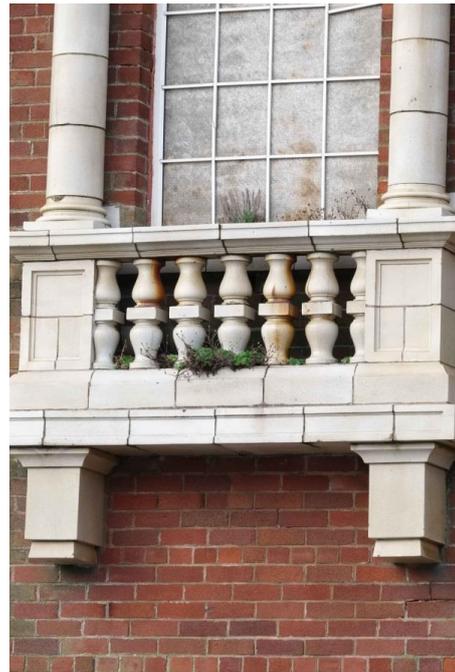
Plant growth on decorative faience
