BUILT HERITAGE AND CONSERVATION SERVICE
PROPOSED MARTON MOSS CONSERVATION AREA
CONSERVATION AREA APPRAISAL
AUGUST 2018

MARTON MOSS CONSERVATION AREA

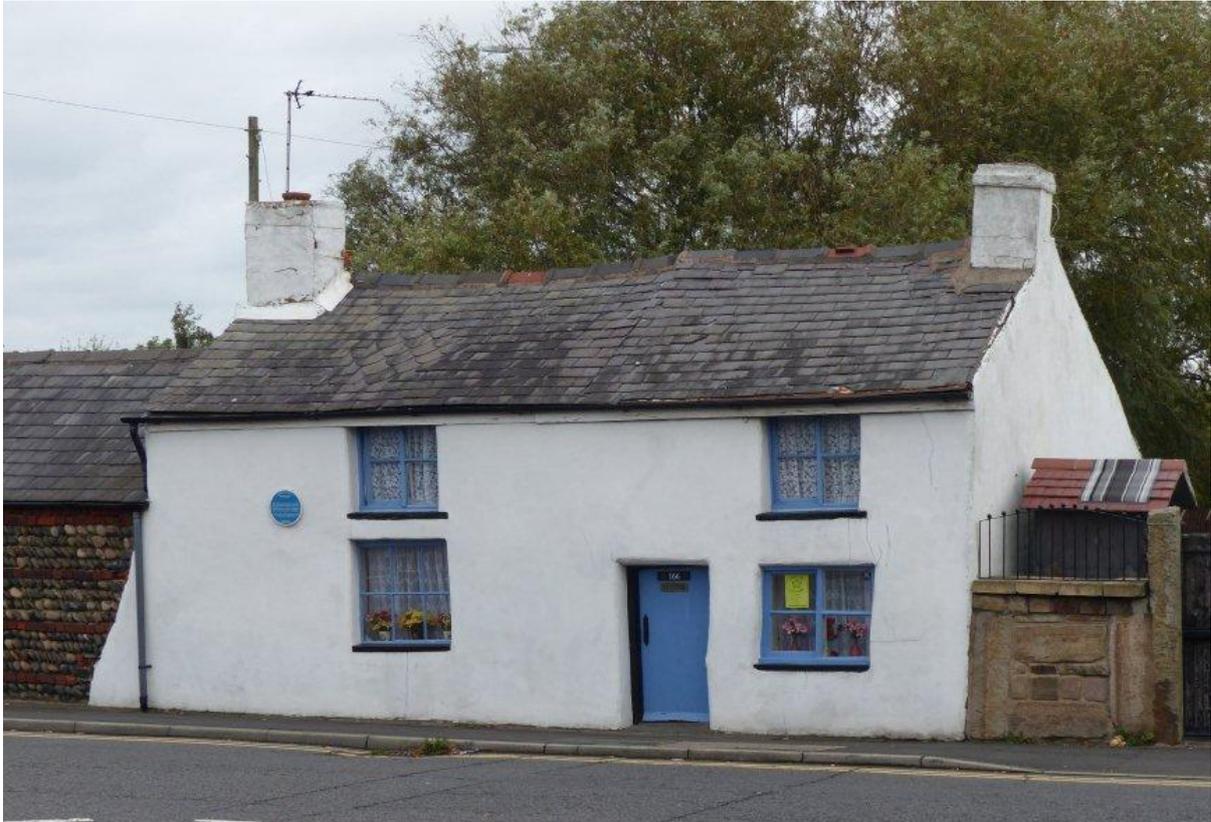
Blowing Sands, Common Edge Road

- 6.2 Most of the cobble cottages on Marton Moss dating to the 18th century or earlier have been demolished, or altered to the extent that their historic origins cannot be recognised. The most prominent remaining cobble cottage is the grade II listed Blowing Sands, which sits on a busy junction far removed from its original setting.

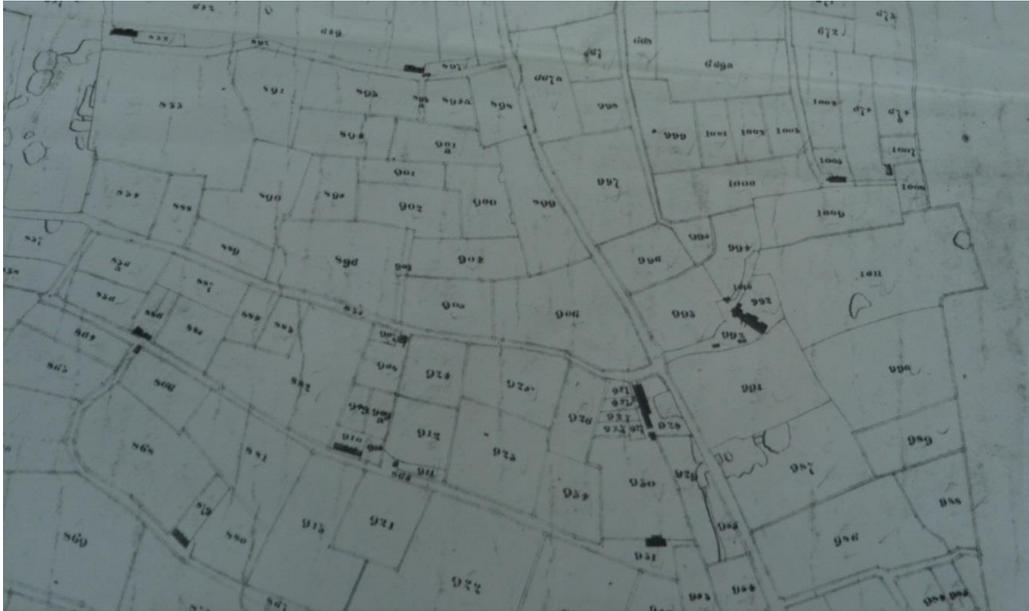
Extract from 1839 tithe map. Midgeland Farm is set in the middle of field 992

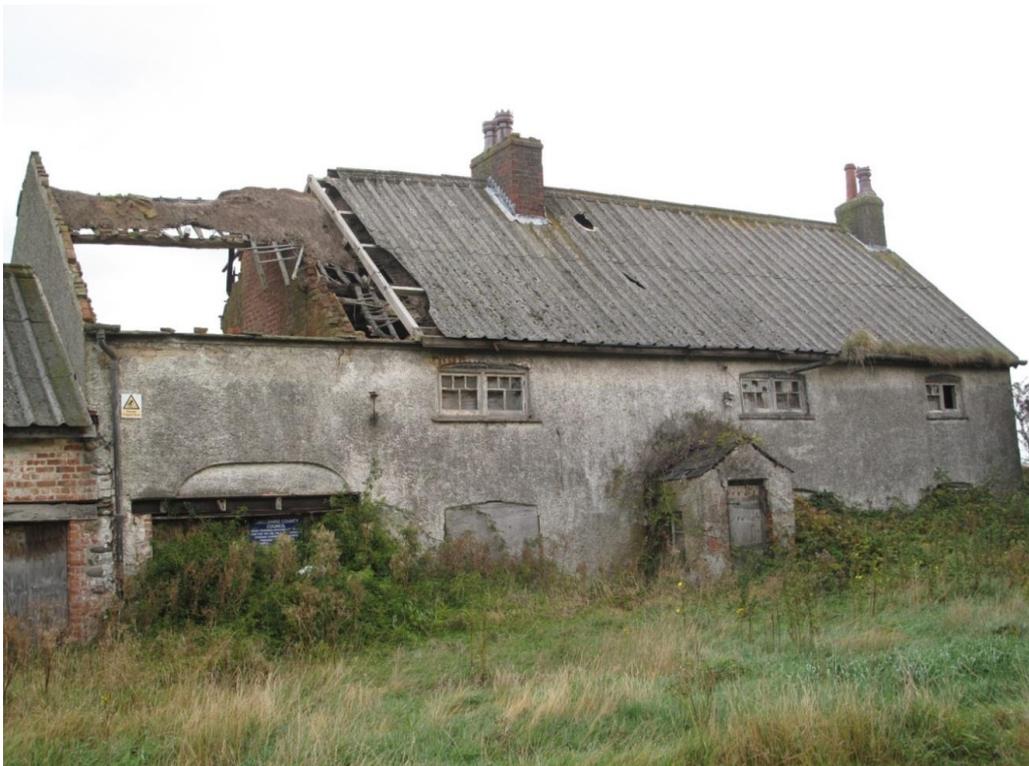
Locally listed Midgeland Farm in an advanced state of disrepair

- 6.4 Locally listed Midgeland Farm was probably originally completely cobble built and, in its rural setting, is the least compromised of the Marton Moss historic buildings. The current farmhouse is probably early 19th century re-constructed from handmade brick, with earlier attached cobble built barn and shippens with brick patch repairs. Unlike other 'improved' farmhouses, which were usually roofed in slate, Midgeland retains its thatched roof under the damaged asbestos sheeting, which suggests it was one of the earlier sites to be altered. The farmhouse sits on the edge of a former landfill site owned by Lancashire County Council, and is currently in a dilapidated state. It is surplus to Lancashire County Council's requirements and potentially at risk of demolition.

- 10.1 The cobbled buildings which were once so common in this area are now few in number. Midgeland Farm is a locally listed building which has been allowed to fall into decay. Its repair and conservation should be seen as a high priority as it is one of the key historic buildings in the area.

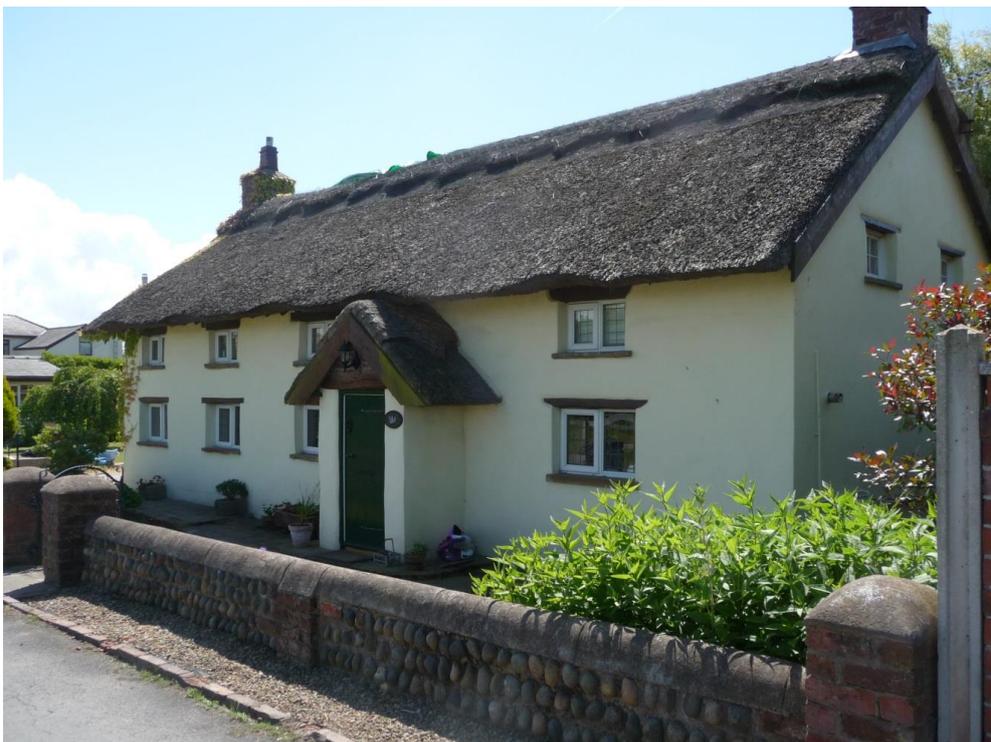
- 6.6 The locally listed Butcher's Farm Cottage on Worthington Road is late 19th century but maintains the Moss tradition of thatched roof covering.

Butcher's Farm Cottage, Worthington Road

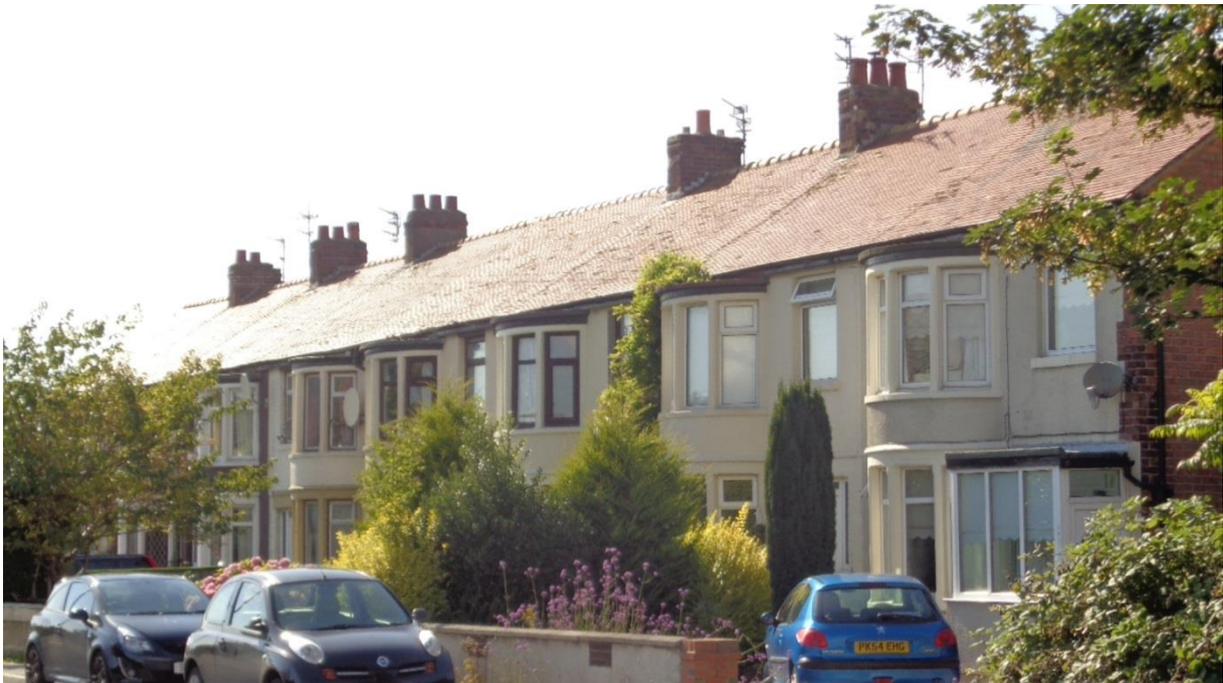
- 6.11 The terrace to the east of St. Nicholas primary school close to the intersection was built c. 1935 and is a typical design of the period with double height curved bay windows. The front elevation is rendered and painted, and the red tile roof covering makes an attractive contribution to the streetscene, although some of the boundary walls have been removed which undermines the uniformity of the terrace.

Nos. 181 – 195 School Road

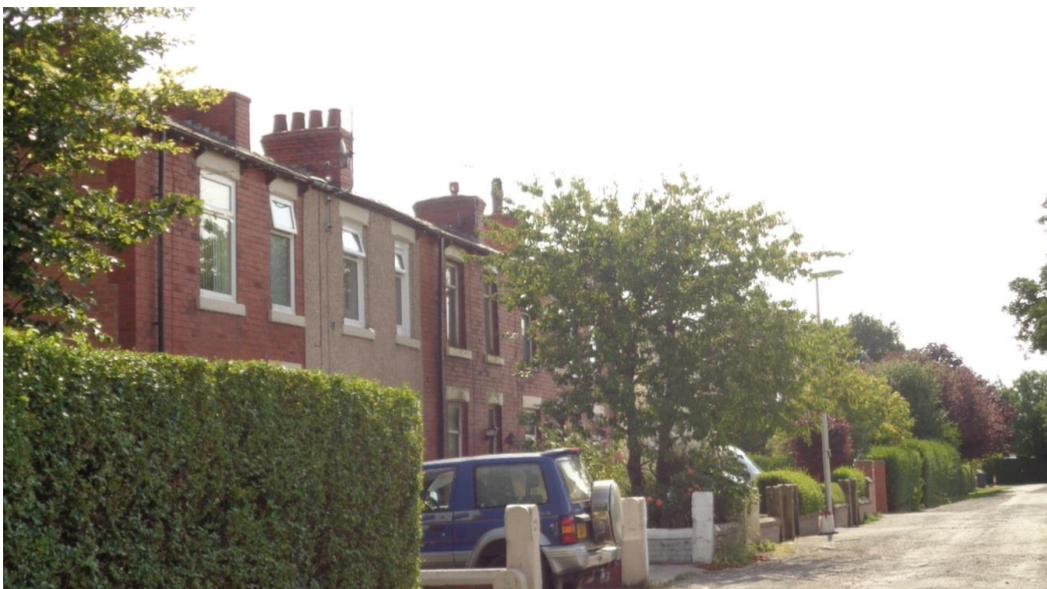
- 6.18 The south side of Laundry Road has limited late Victorian development in the form of terraced housing, and a handful of detached dwellings where it turns north, together with some glasshouses.

Terraced housing on Laundry Road

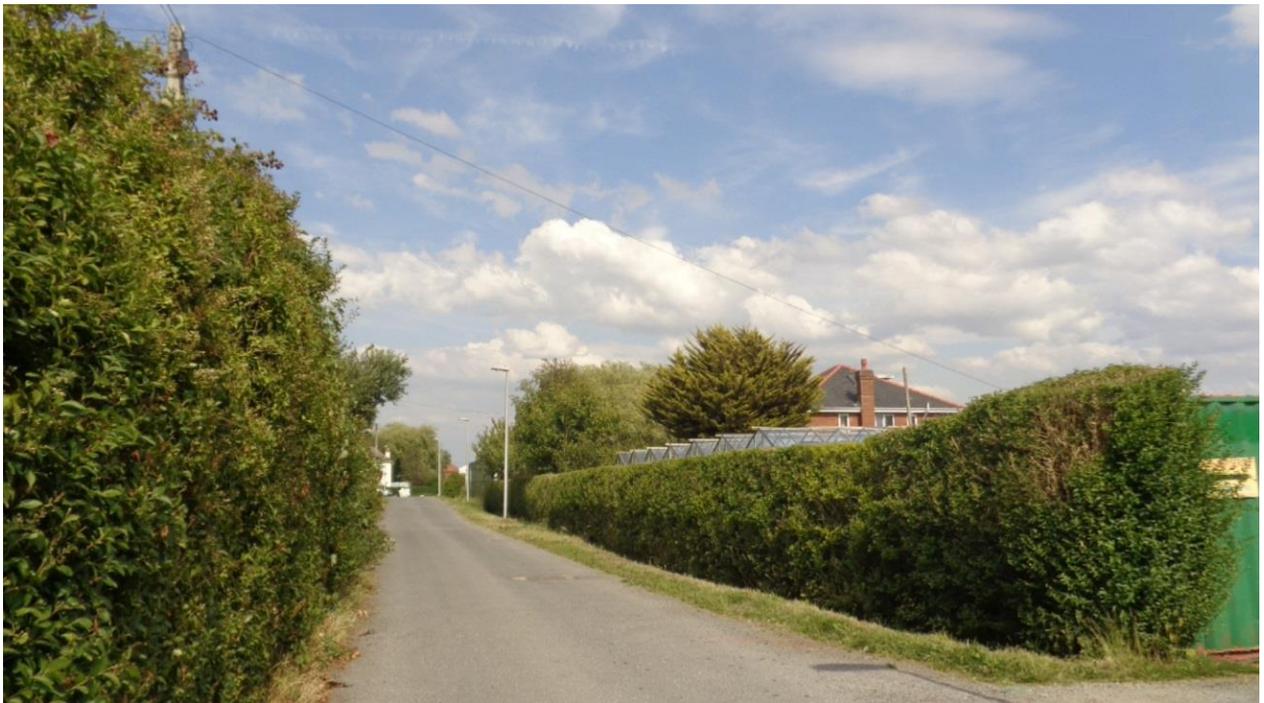
- 6.19 New Hall Avenue is given over largely to glasshouses to the south with a few detached dwellings where it turns to the north. This lane also has an enclosed feel being lined with hedgerows.

Glasshouses visible behind the hedge on New Hall Avenue

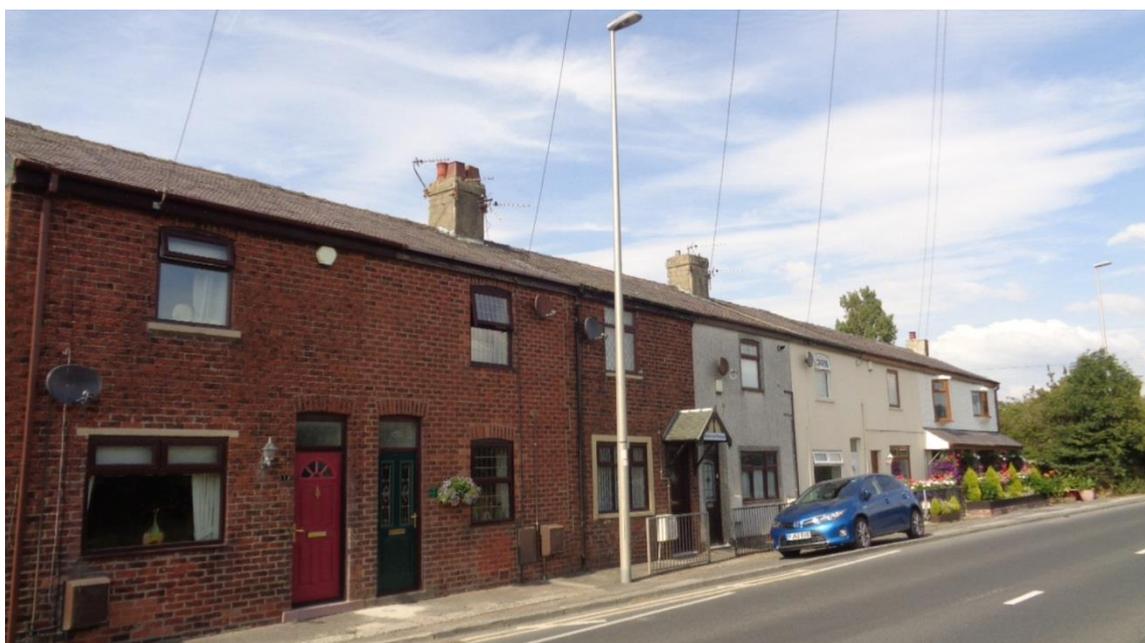
Late Victorian terrace in area formerly known as Little Midgeland

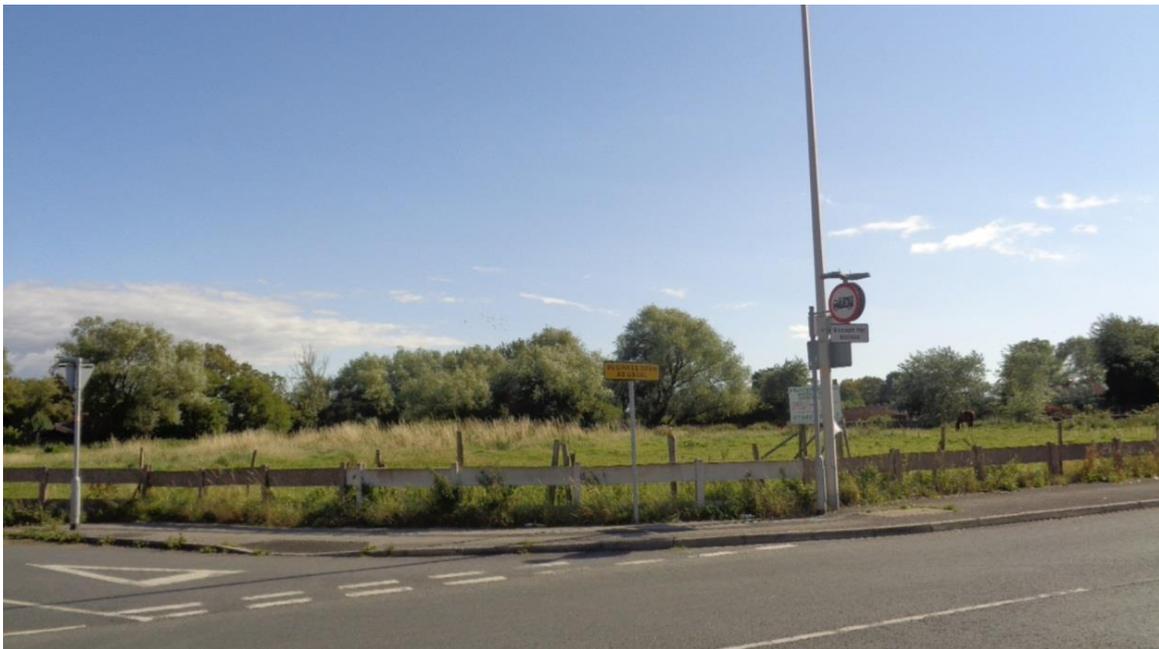
- 8.1 The majority of the boundaries in the area are formed by hedgerows which line the roads and lanes.
- 8.2 The open land at the intersection with School Road has a variety of boundary treatments. The south west paddock is surrounded by timber fencing whilst the paddock to the north east has concrete railing which is missing in places.

Timber fencing to south west paddock

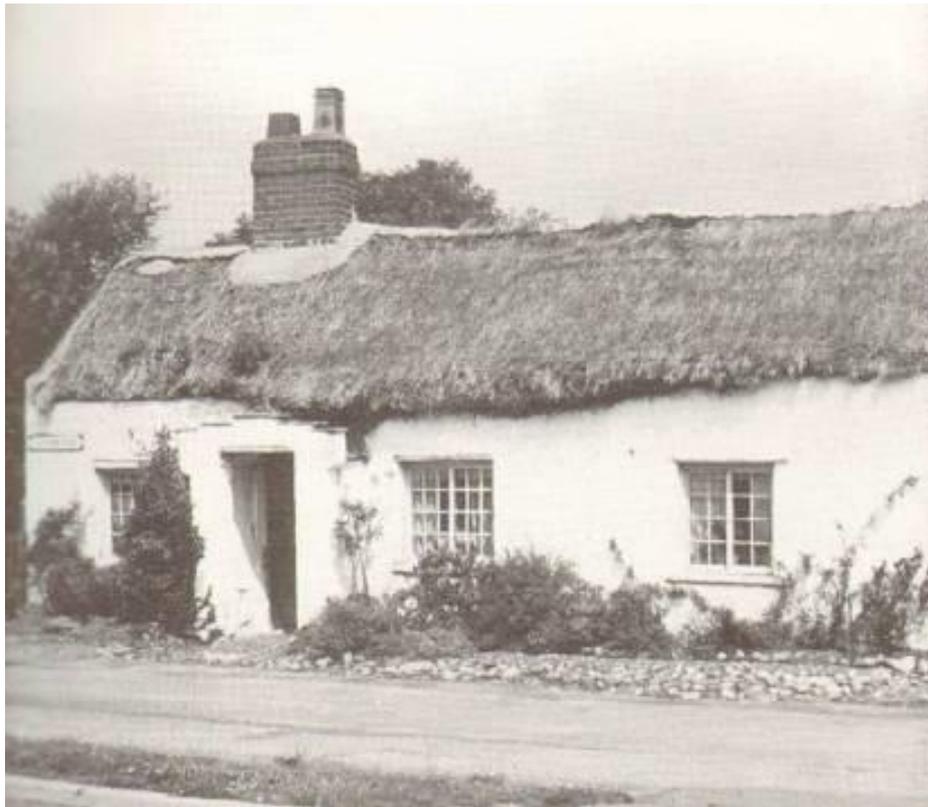
Typical Fylde longhouse, now demolished
