Heritage Assessment

137 Preston New Road
Blackpool
FY3 9NG

February 2023

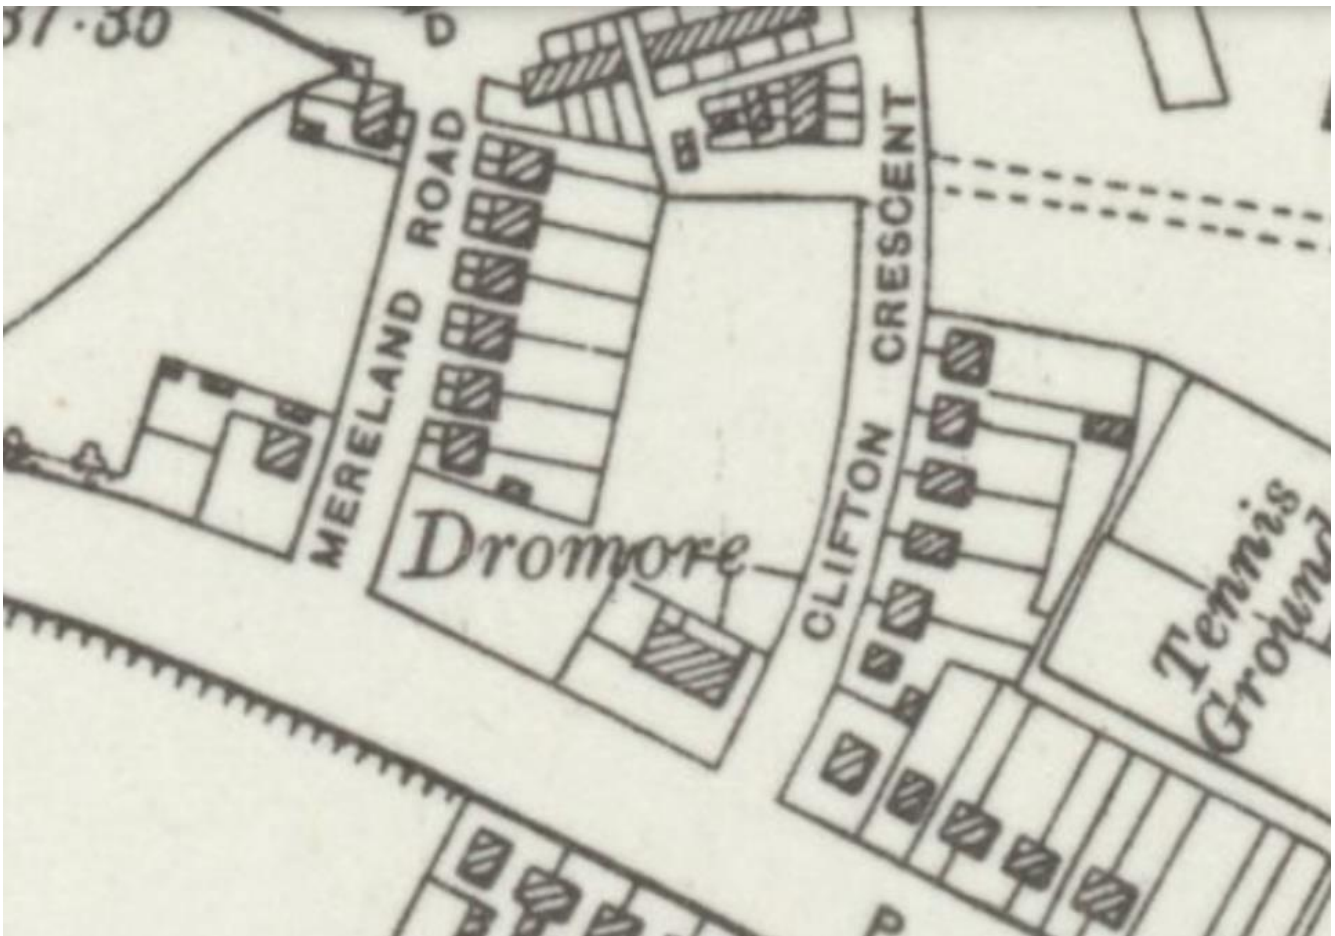
Figure 2: OS Map 1930/31, Published 1933 (Lancashire Sheet LI.SW)

- 4.2.4 The 1930/31 OS Maps (Published 1933) shows a property, again referred to as 'Dromore' at the site. Significant development has also taken place within the surroundings, including the creation of a number of streets, including Clifton Crescent immediately east of the property. This map again shows a rectangular property, however, this is now set within a larger plot with a diagonal rear boundary. From a review of the Conveyances in relation to this property, it can be seen that this additional land was purchased by Helen Gill in 1922.

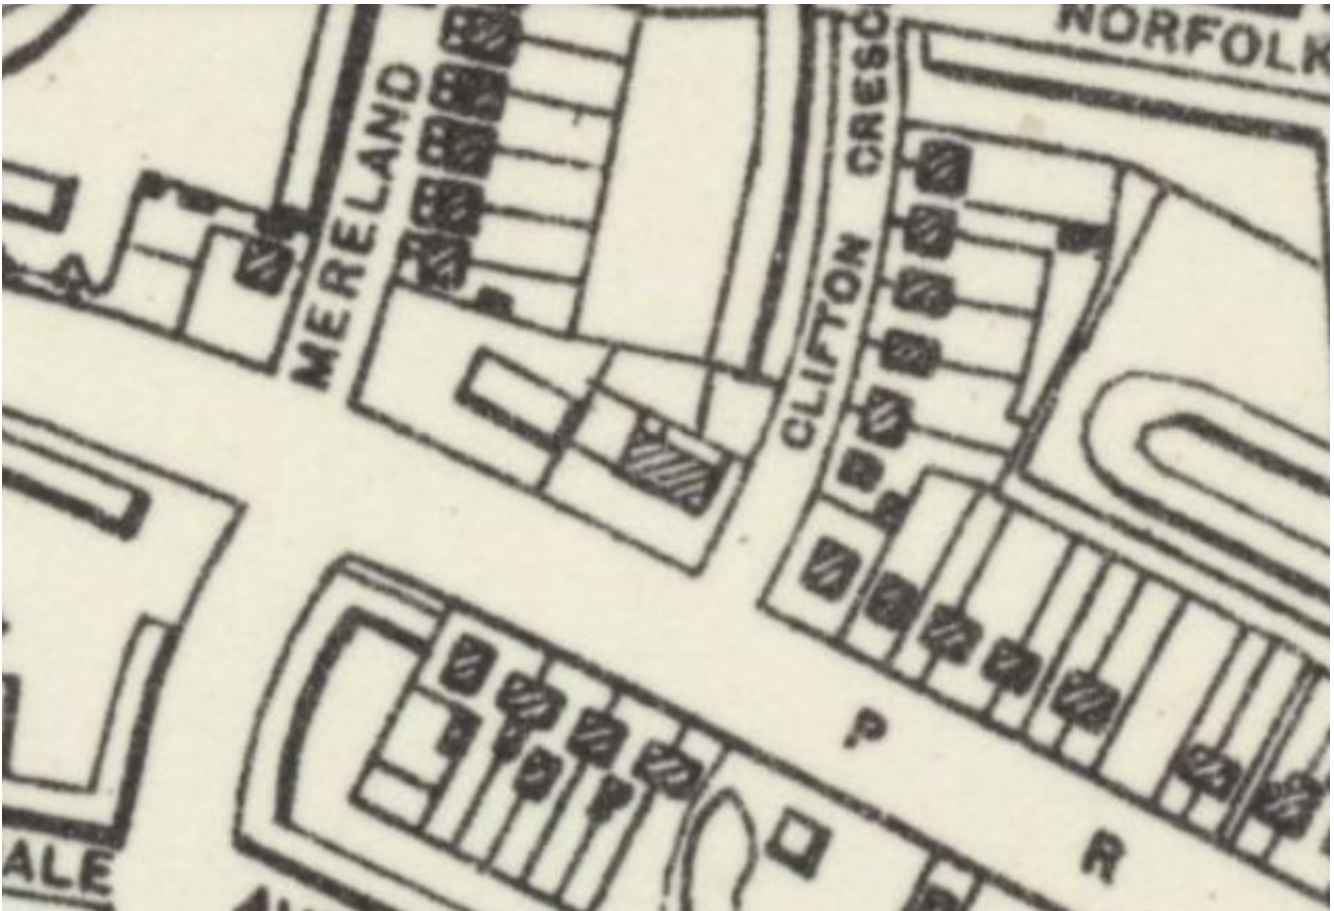
Figure 3: OS Map 1938, Published 1945 (Lancashire Sheet LI.SW)

- 4.2.5 By 1938, the plot to the west saw development, with a large rectangular shaped property having been erected. At this date, 137 Preston New Road remains unaltered to the 1930/31 OS Map, however, as of 1938 the property is no longer detailed as 'Dromore' and no subsequent records refer to the property with this name. It has not been possible to confirm why the property name was abandoned, however, it is noted that the registered address for this property is '137 Preston New Road' and not 'Dromore'.

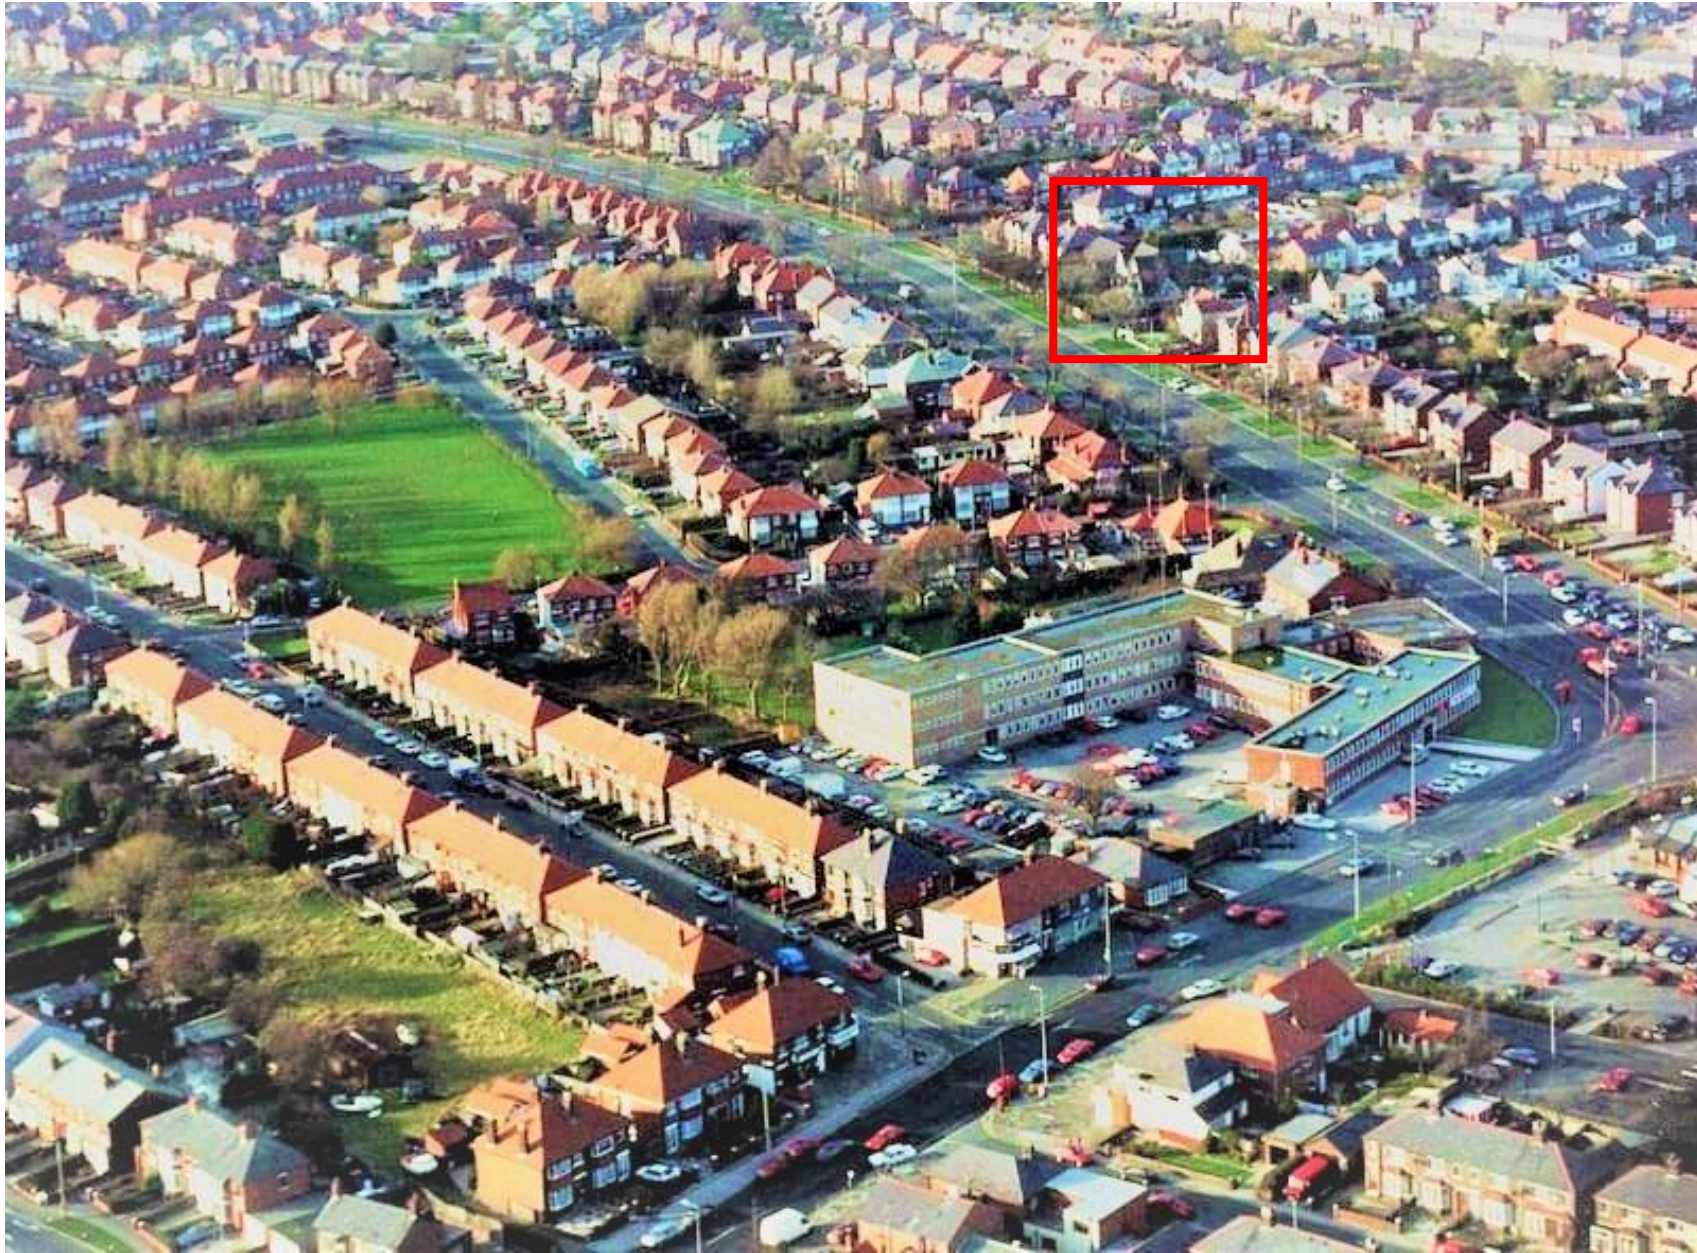
Figure 5: Blackpool Gazette Offices, c.1980s (Source: The Gazette)

- 5.3.16 Furthermore, and as shown in the imaged dated to c.1980s, there has been significant alteration to the roofline of the property on the east elevation. The image shows the roofline continuing north with a white rendered chimney stack present, the other two chimney stacks already removed. The roofline on the property today is cut back in this location at an unusual angle and this last chimney stack has been removed. It's also noted from the photograph that the chimney stack that was in situ is not oversized, as was common with Arts and

Crafts style properties. This chimney shown in the photograph is more in keeping with surrounding 20th century properties.

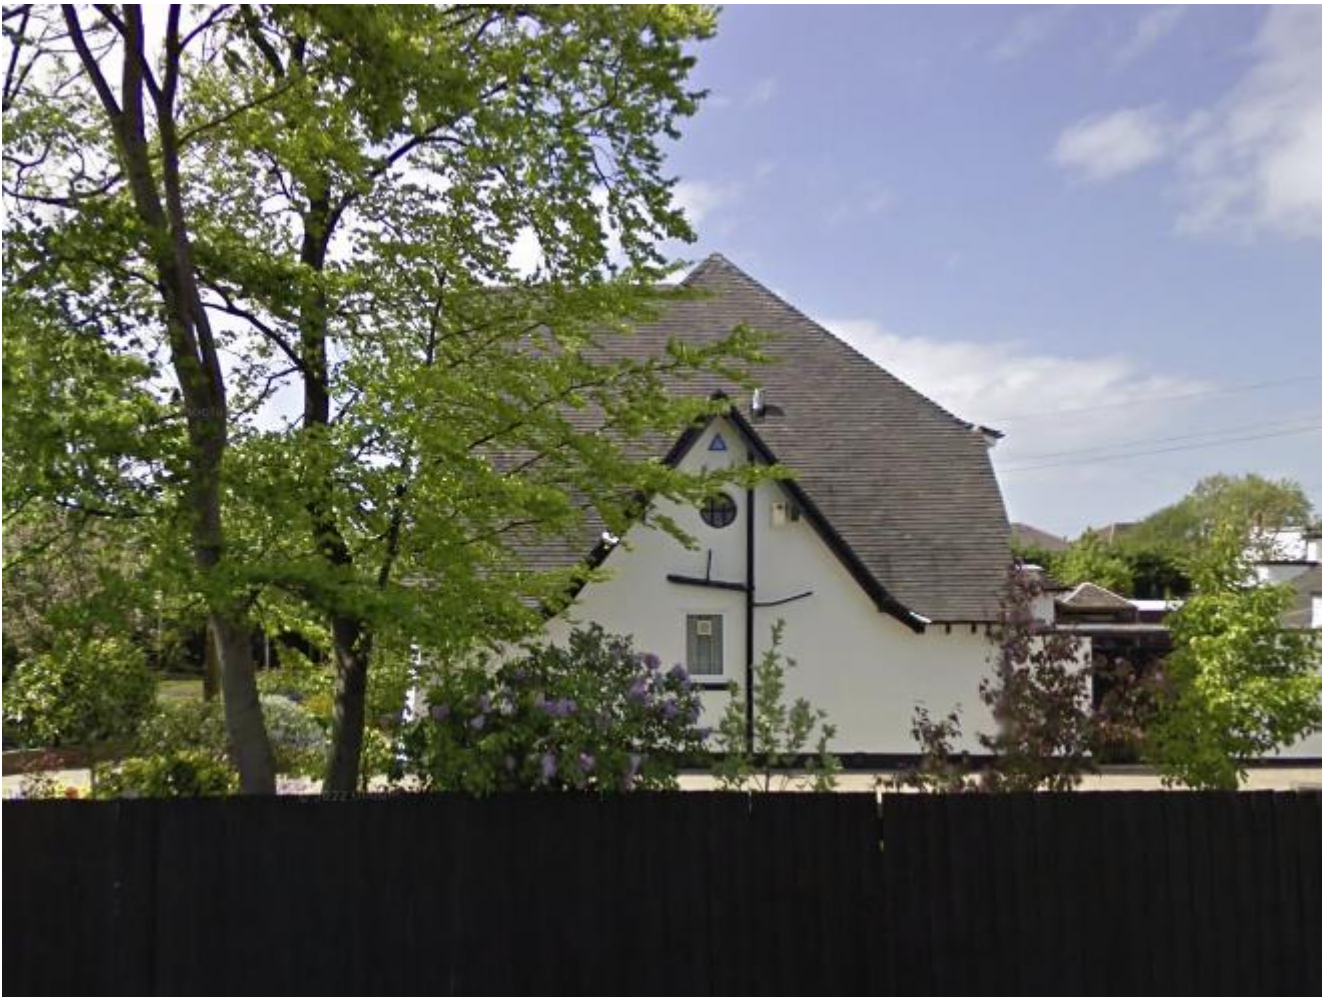
Figure 6: First-Floor Side Window non-Stained in 2009 (Source: Google Maps)

- 5.3.19 To the side and rear elevations non-original UPVC windows are again found, except these windows do not have the mock sash effect.
- 5.3.20 The main dwellinghouse has two small round timber framed feature windows within the east side extension (one facing the east and one the south). However, upon inspection of the property it has been noted that these two windows are identical to the small round timber framed feature window in the garages front elevation. The garage is a non-original outbuilding and so the authenticity of these feature windows is questioned. The east facing round window is currently stained glass, however, review of Google Maps images show that in 2009, this window was not stained, therefore suggesting the stained glass has been inserted at a later date, possibly when the ground floor window on this elevation was replaced with a non-ventilated window.
