# Section 19 Report: Investigation into flooding on 22<sup>nd</sup> November 2017

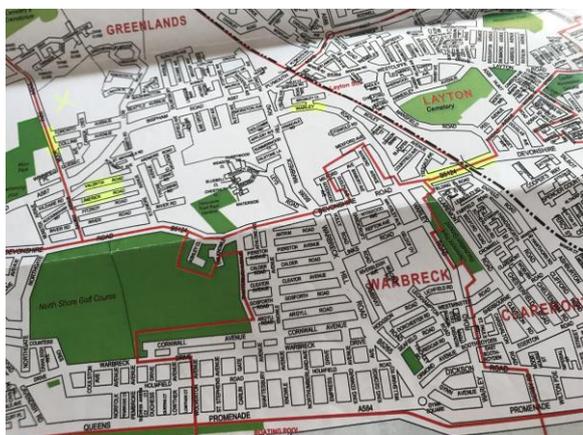
Plan A Bispham

Plans A and B provide the location of some of the properties listed above that had flooding reported.

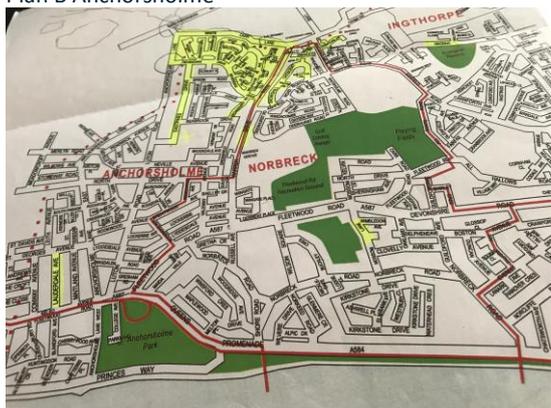
Plan B Anchorsholme

In the Anchorsholme area identified in Plan B, as a result of the weather conditions during the week commencing 20<sup>th</sup> November, the sewage system was already full to capacity, ground conditions were saturated and water course levels were high.
